2005 5TH AVE

LANDMARKS PRESERVATION BOARD MEETING
PROJECT NUMBER: 3028017
MEETING DATE: 03/15/2023

GRIFFIN & SHERIDAN STRUCTURAL CONDITIONS

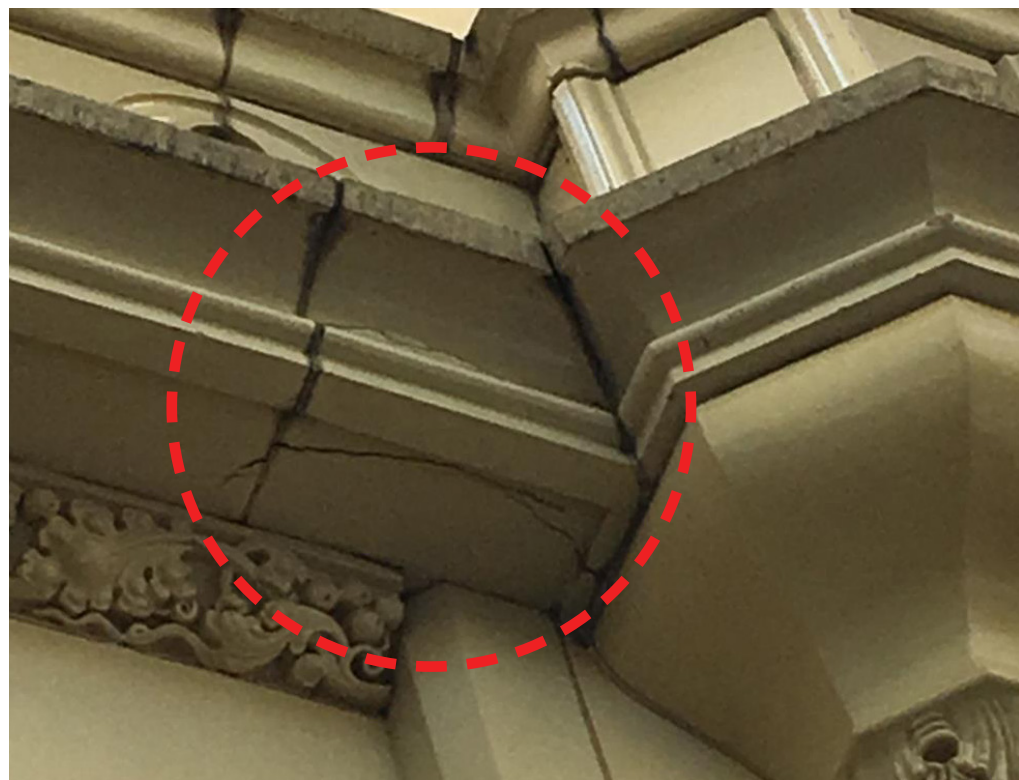
CRACKED TERRACOTTA

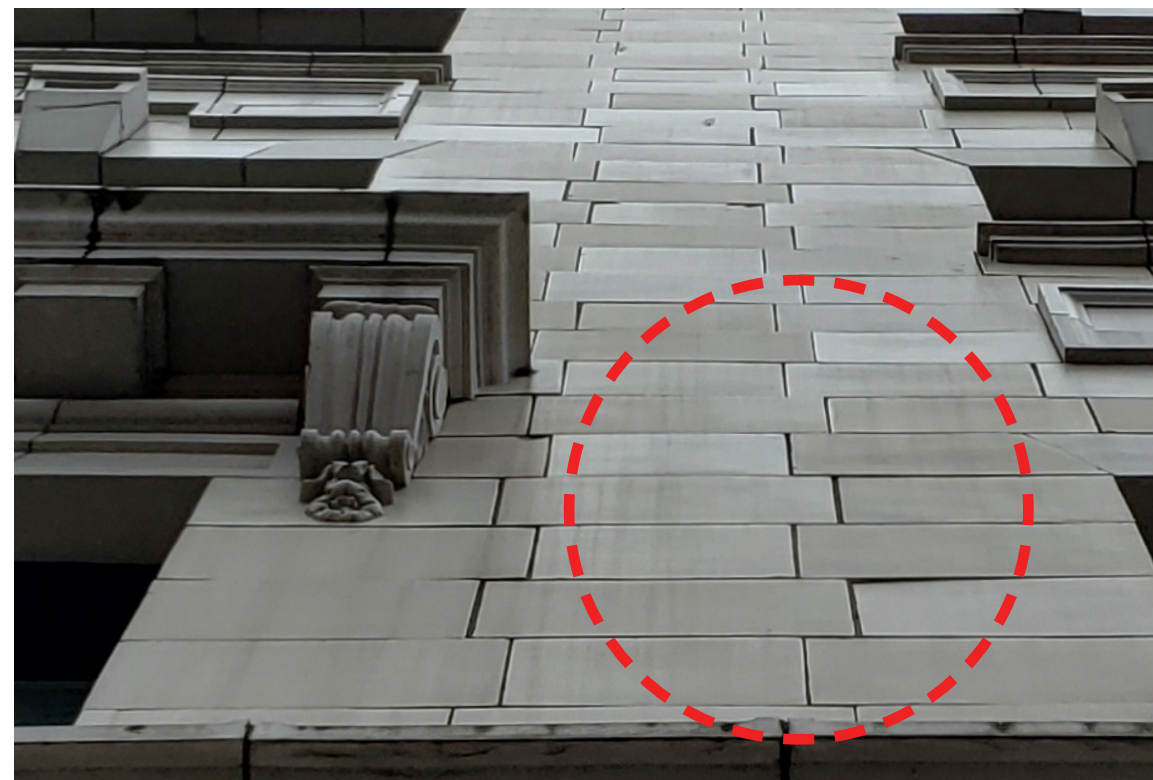
OFFSET & SPALLING TERRACOTTA

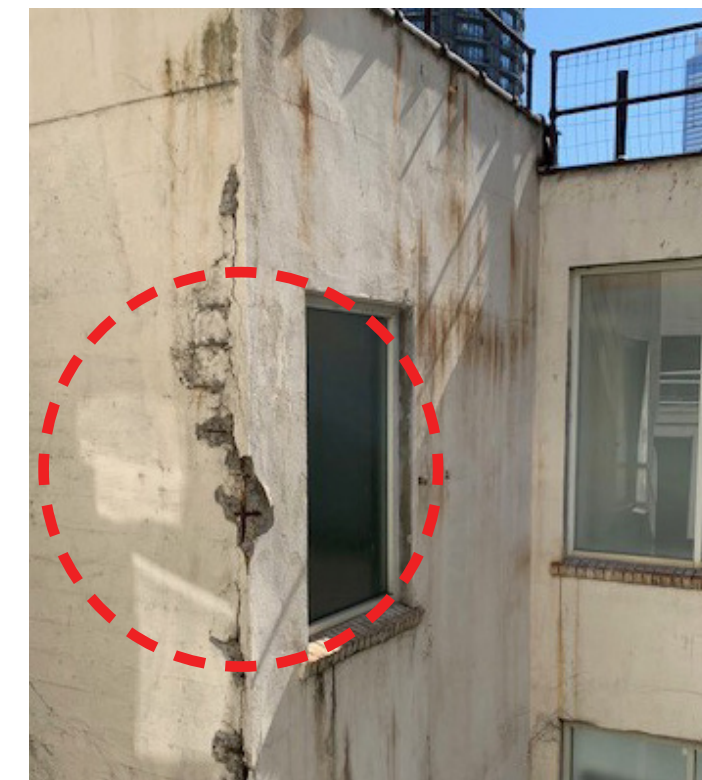
RUSTED/EXPOSED STEEL

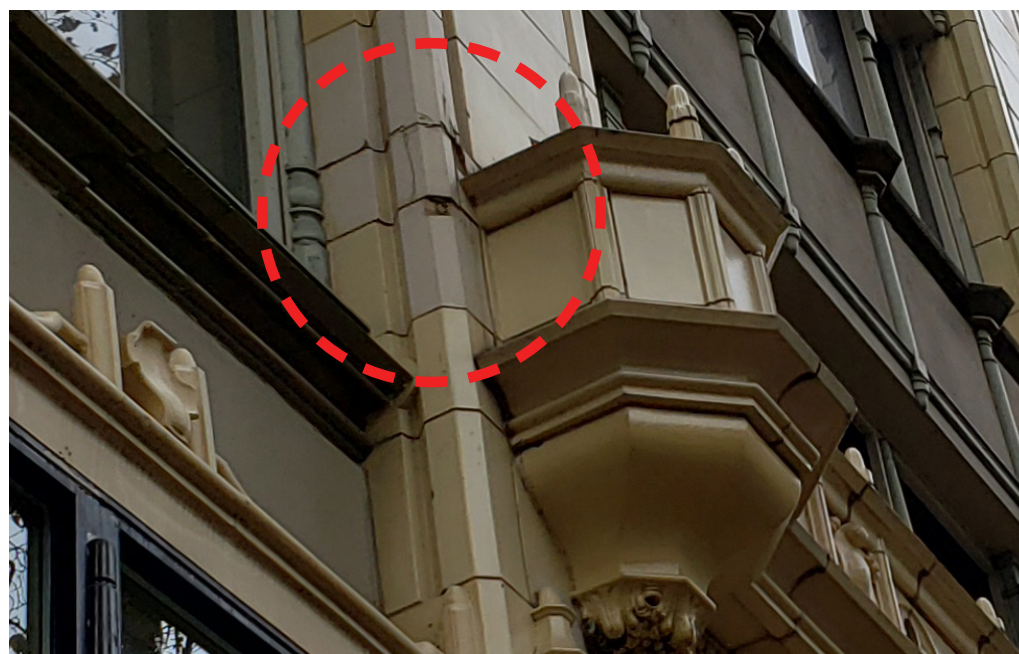
SETTLEMENT DAMAGE

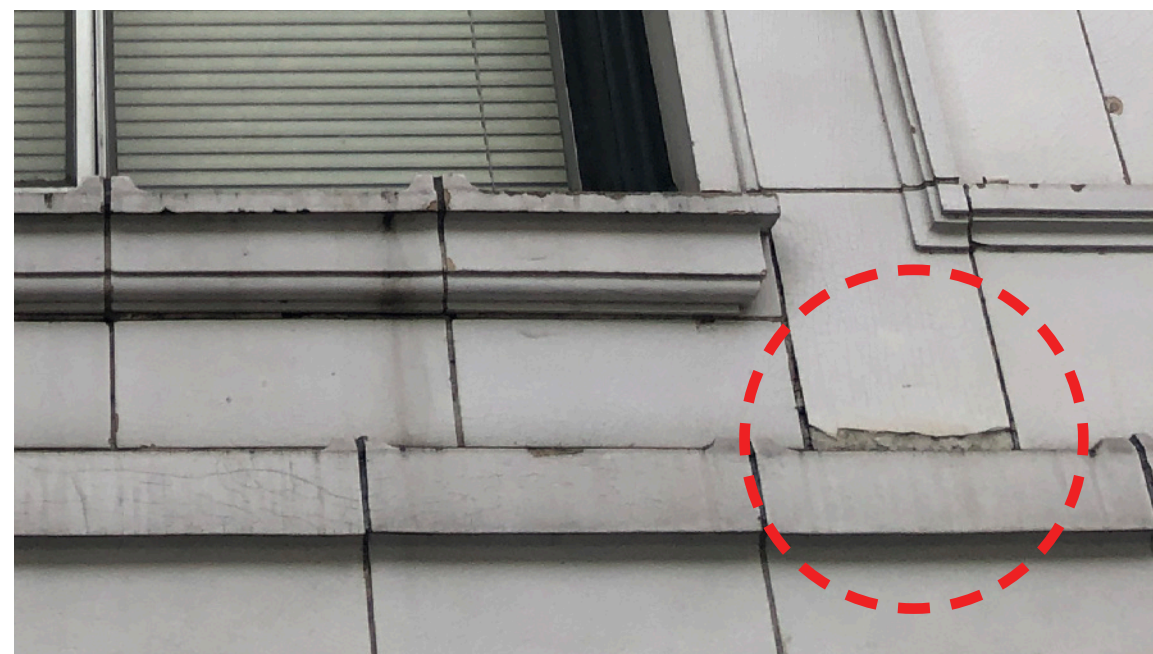
OFFSET & SPALLING TERRACOTTA

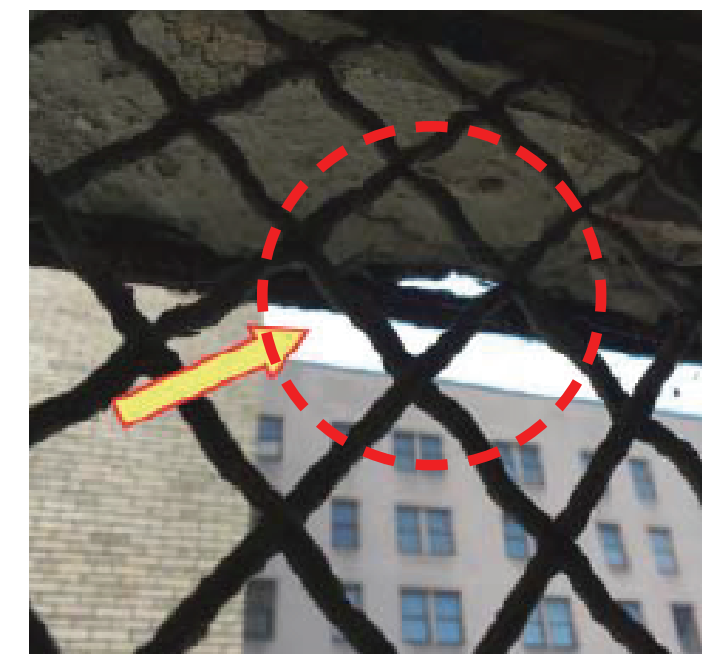
RUSTED/EXPOSED STEEL

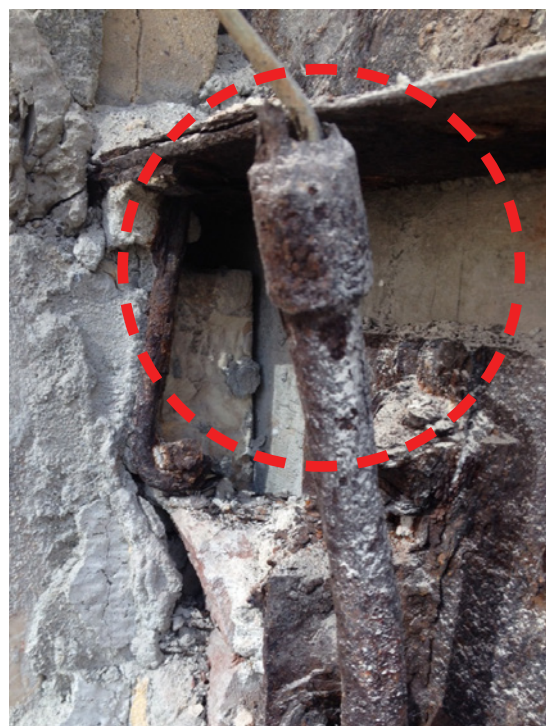
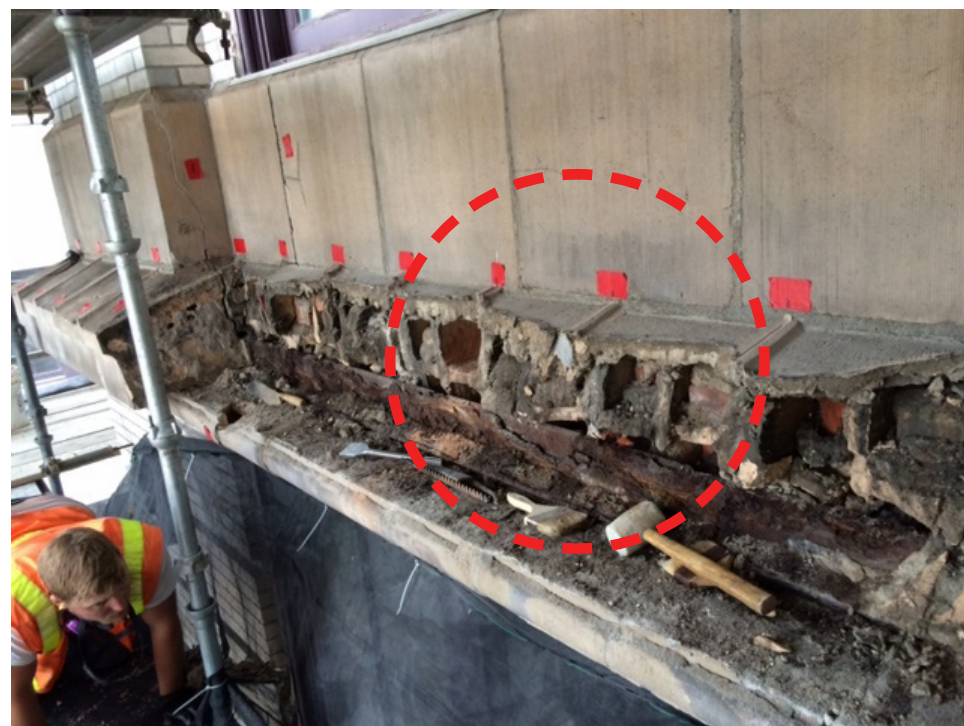
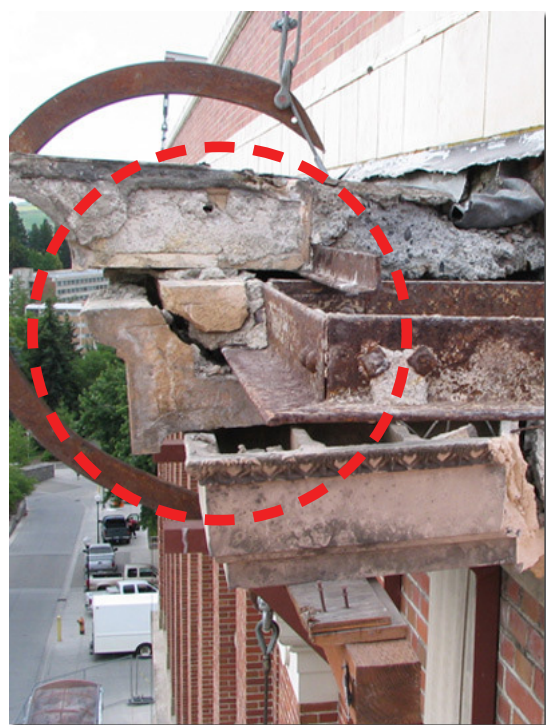
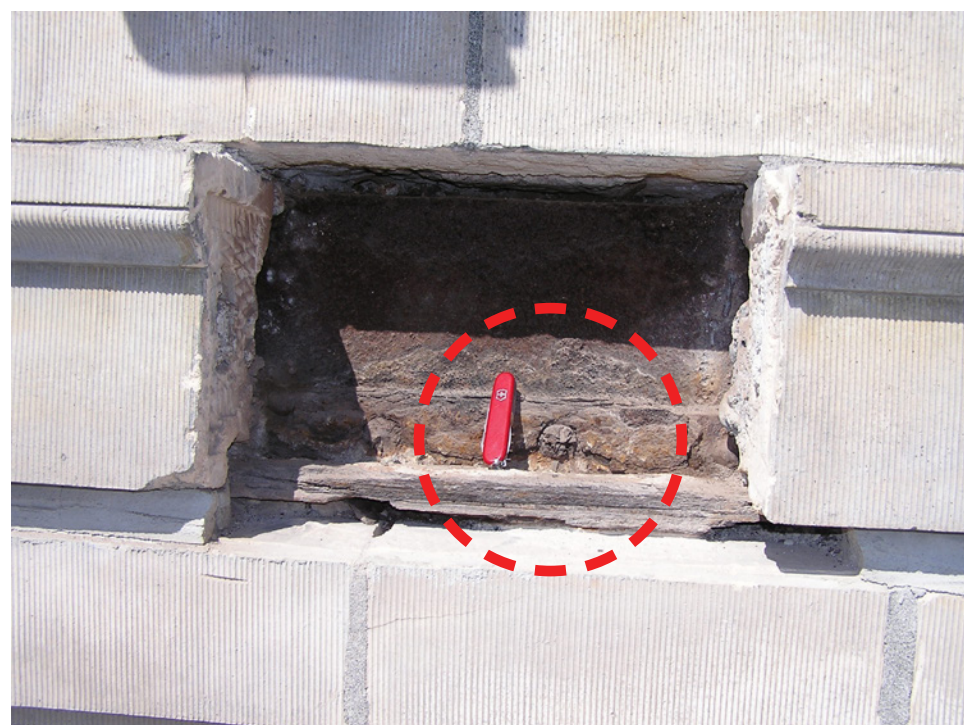
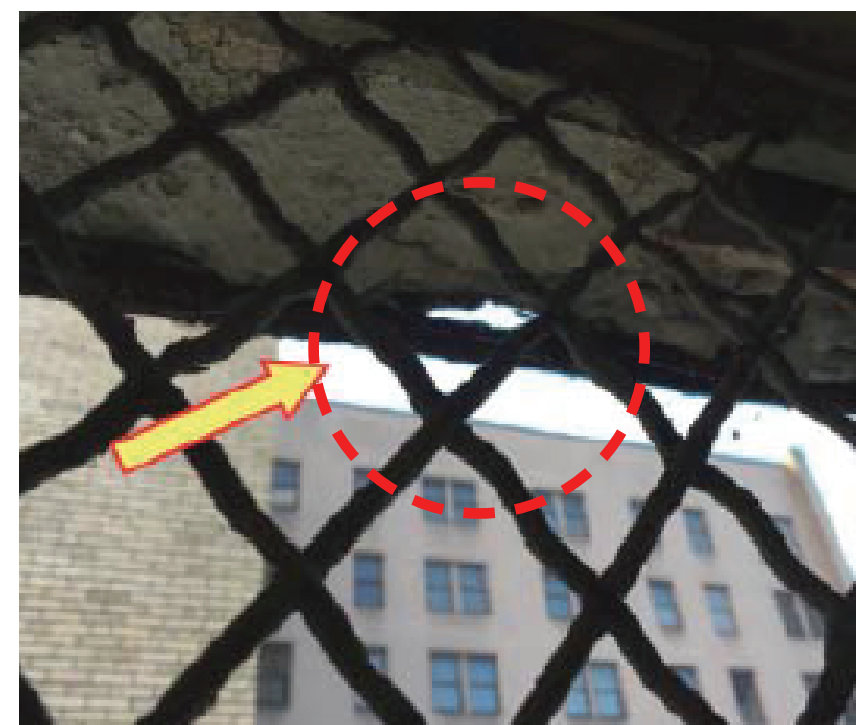
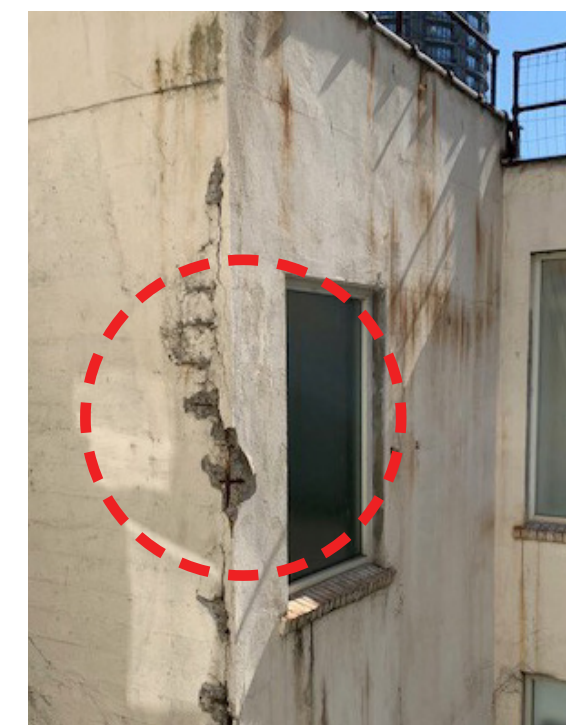
Oxide Jacking

- Brick and masonry facades are not waterproofed and there was no waterproofing barrier in old buildings
- Masonry is porous for water intrusion
- The phenomenon of facade damaged by corrosion of the structural steel is "Oxide Jacking"
- Results are compromised hangers, attachment points, ledgers and damage to the terra cotta units
