2005 5TH AVE

LANDMARKS PRESERVATION BOARD MEETING
PROJECT NUMBER: 3028017
MEETING DATE: 03/15/2023

GRIFFIN & SHERIDAN STRUCTURAL CONDITIONS

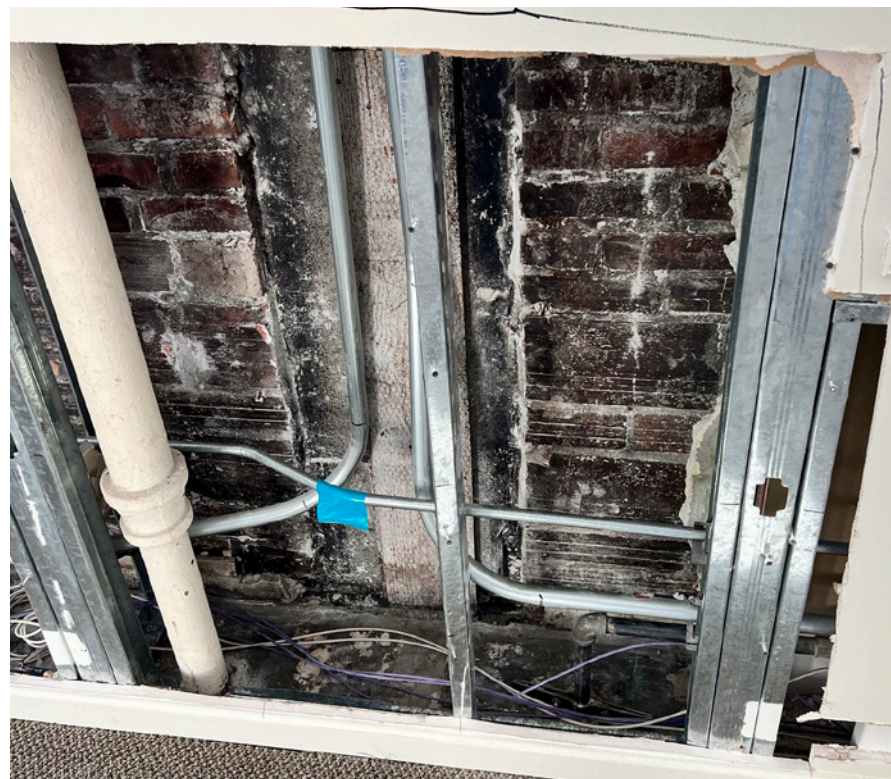
GRIFFIN BUILDING

- Embedded steel vulnerable to corrosion
- Fragility of unreinforced masonry backing
- Indications that corrosion is in progress
- Clay tile is especially fragile
- Poor quality of construction
- Still many unknowns...

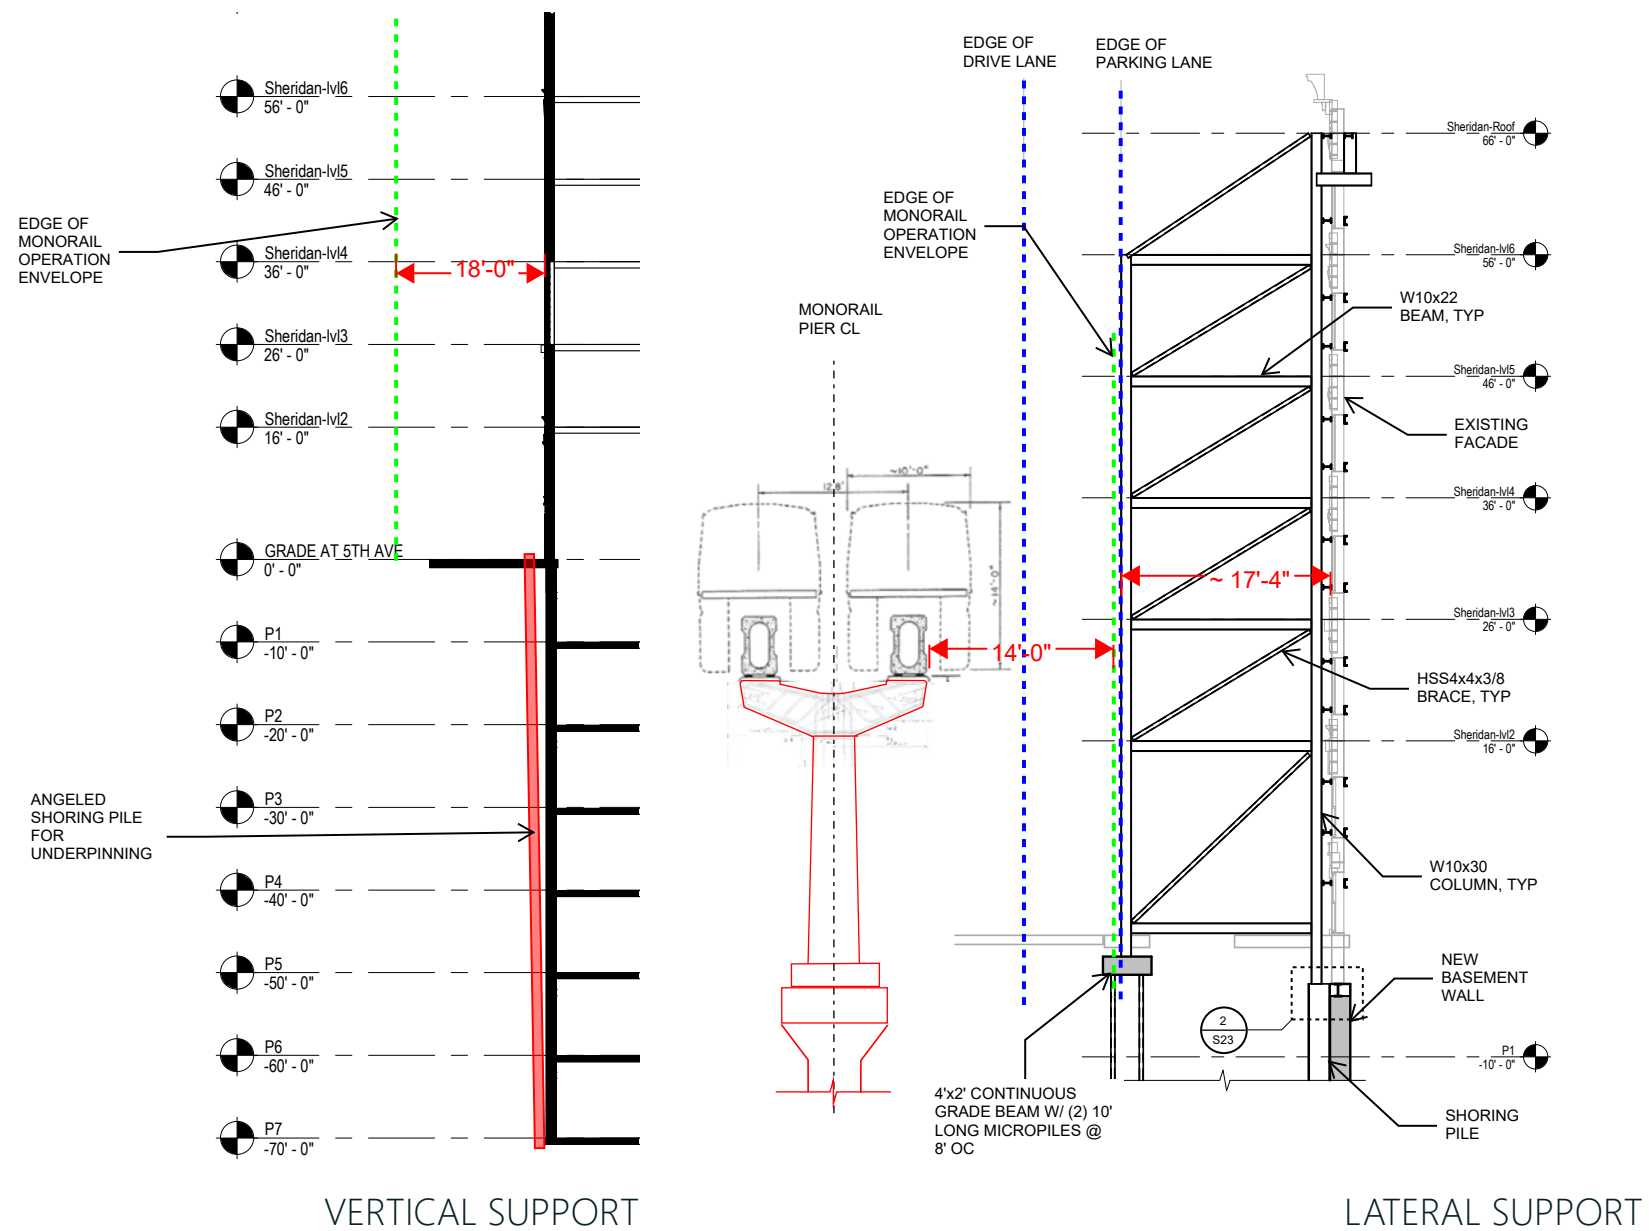
SHERIDAN FACADE BRACING-SECTION AT SOLID FACADE
