MONTLAKE ELEMENTARY SCHOOL

SEATTLE PUBLIC SCHOOLS

**CERTIFICATE OF APPROVAL PACKET FOR SEATTLE LANDMARKS
PRESERVATION BOARD
SUBMITTED MARCH 10, 2023**

Modernization of and addition to the existing landmarked Montlake Elementary School on the same site, removal of all out-buildings and a reconfiguration of the school grounds.

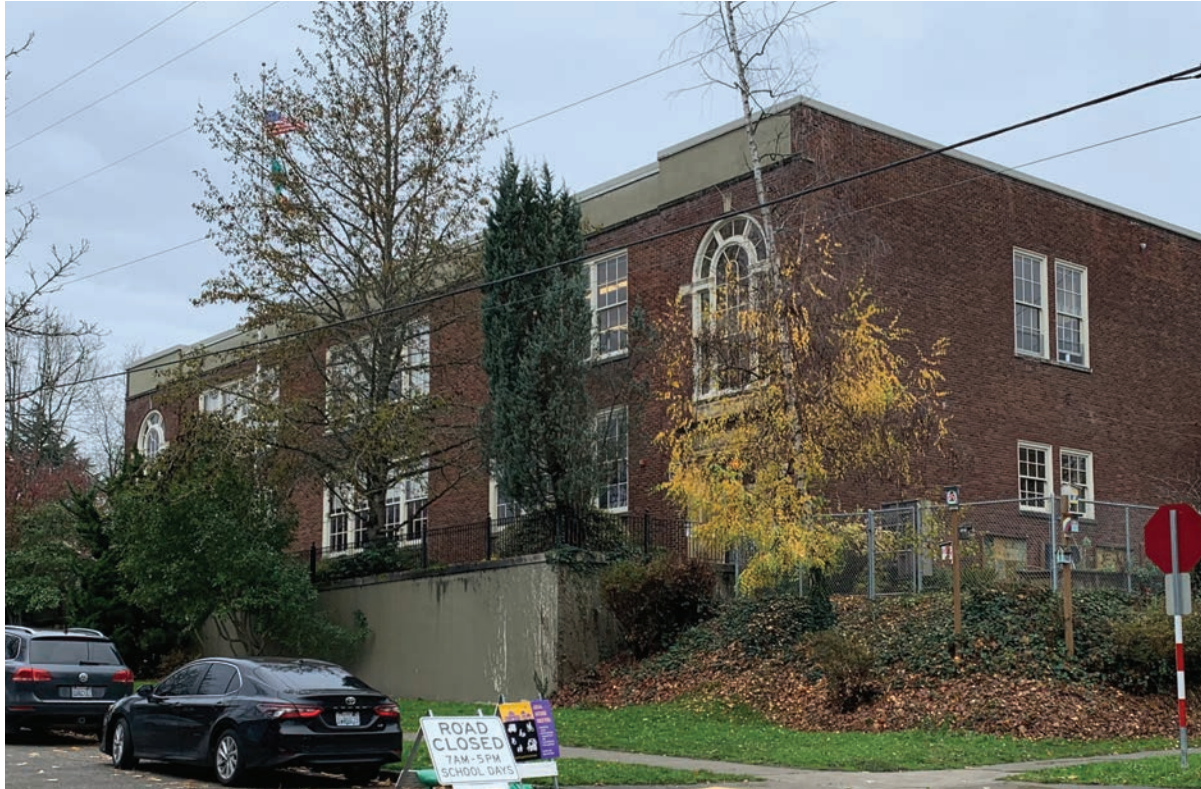
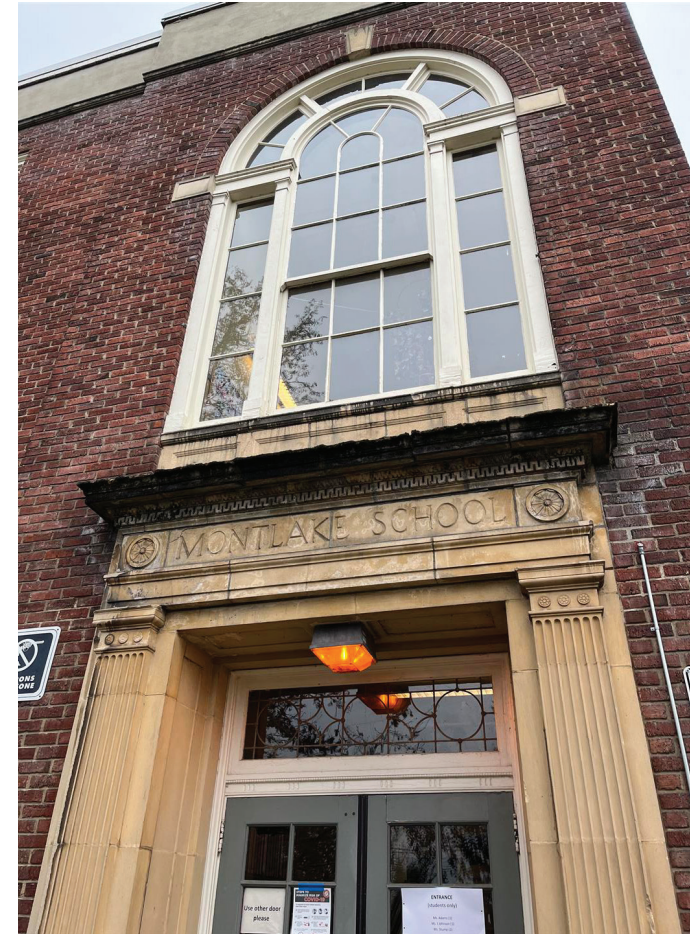
- Overall modest two-story, red brick building with the majority of the distinctive architectural detailing concentrated on the east facade
- Separate main entry doors (appear to have been originally separate entries for female and male students)

- Each entry door is accentuated with cast stone pilasters and an entablature with the school name carved within and flanked with rosettes
- Distinctive arched windows above each entry door that fronts the two primary interior stairwells

- North and south facades are largely devoid of ornamentation and have limited window openings
- Upper floor of the west facade has a similar window arrangement and spacing to east facade

- A wood framed single story structure is connected at the first floor of the west facade and contains a covered play area, the boiler room and the gymnasium

- An engaged chimney runs up the center of the west facade and extends about 20' above the parapet line

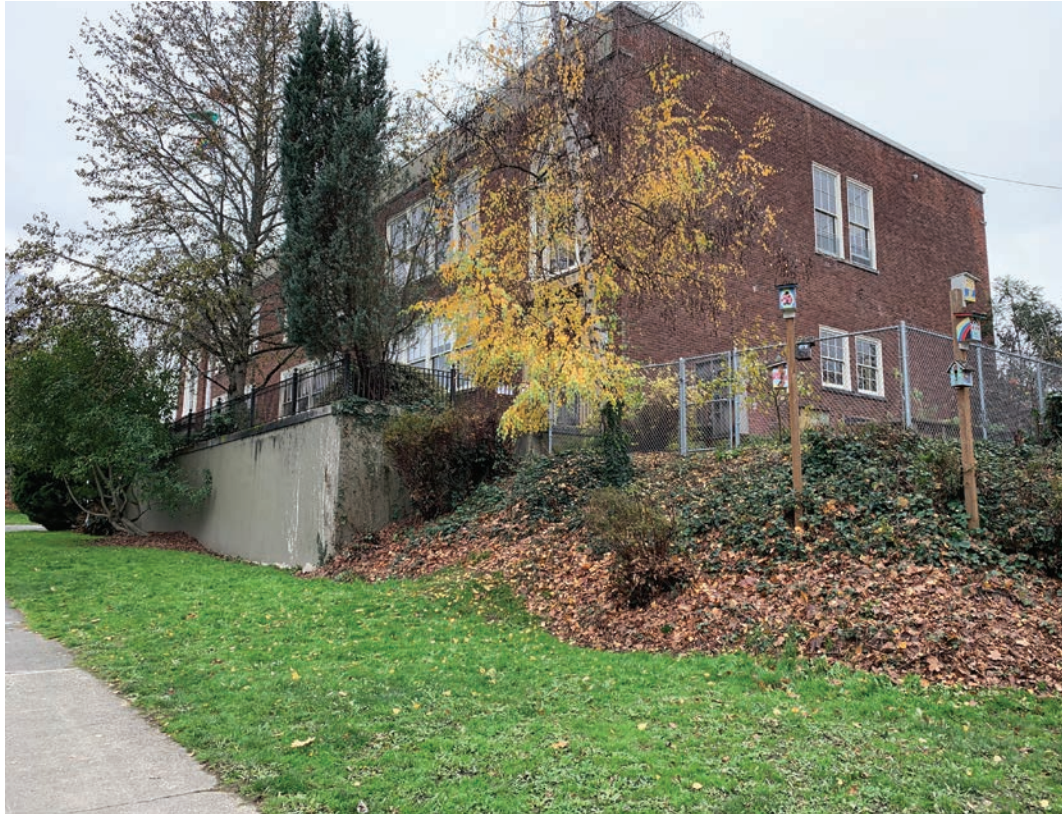
1. View of northeast corner at 22nd Ave E and E Calhoun

1. The corner of 22nd Ave E and E Calhoun is raised considerably from the adjacent sidewalk with the raised base placing the ground floor level of the school well above the sidewalk level.
2. The site slopes upwards along 22nd Ave E towards E McGraw to be more closely aligned with the building ground floor level.
3. The site continues to slope downward along E Calhoun placing the site level above the sidewalk level and creating a berm along the site edge
4. The site slopes upwards along 20th Ave E and along E McGraw. The sidewalk and site levels meet each other along E McGraw near the southwest corner of the historic building

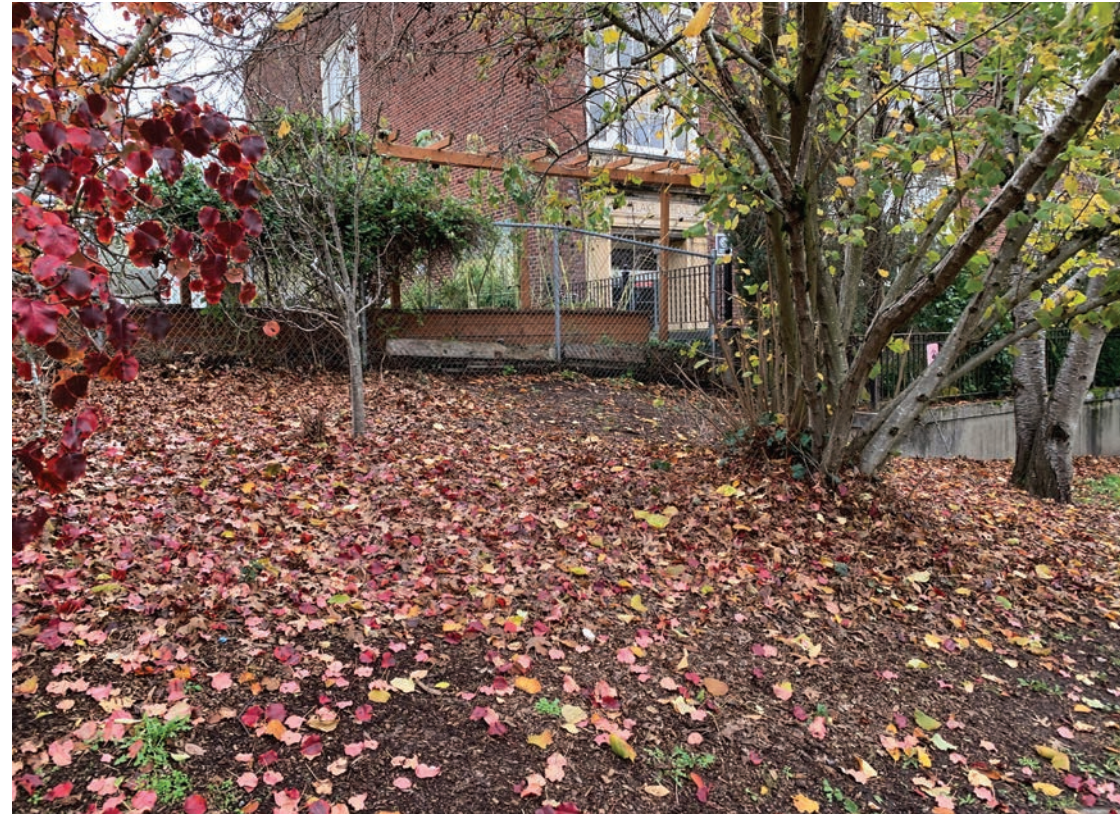
2. View of southeast corner at 22nd Ave E and E McGraw

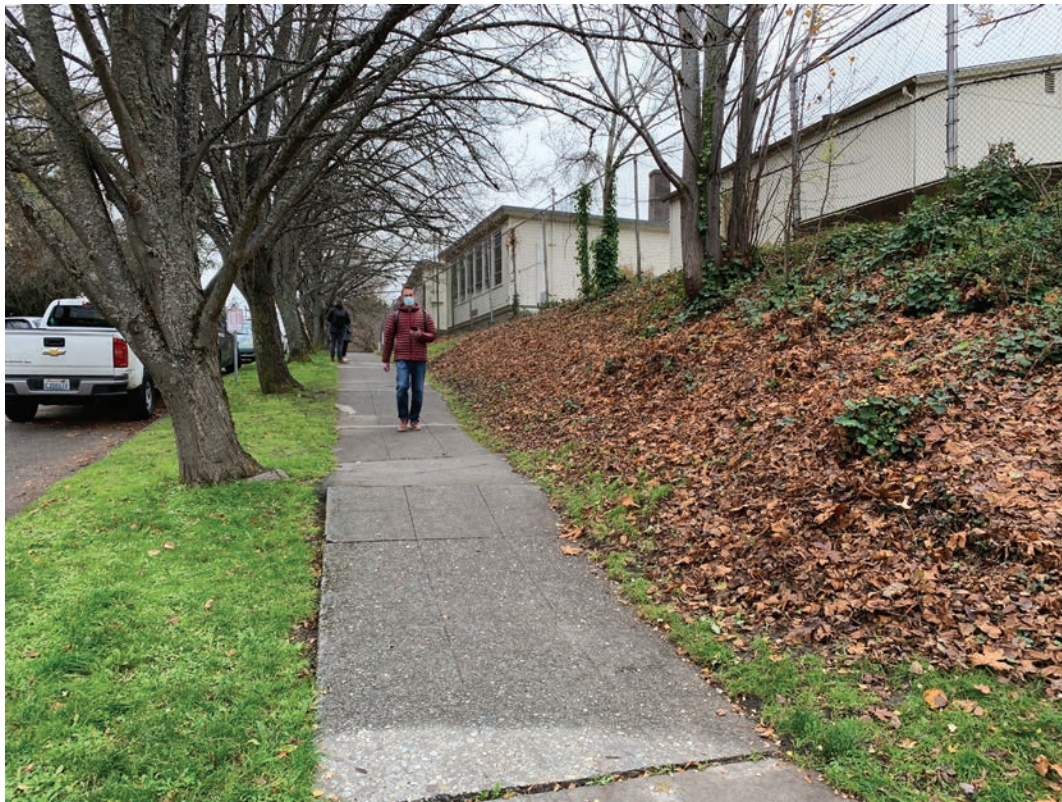
3. View of northwest corner at 20th Ave E and E Calhoun

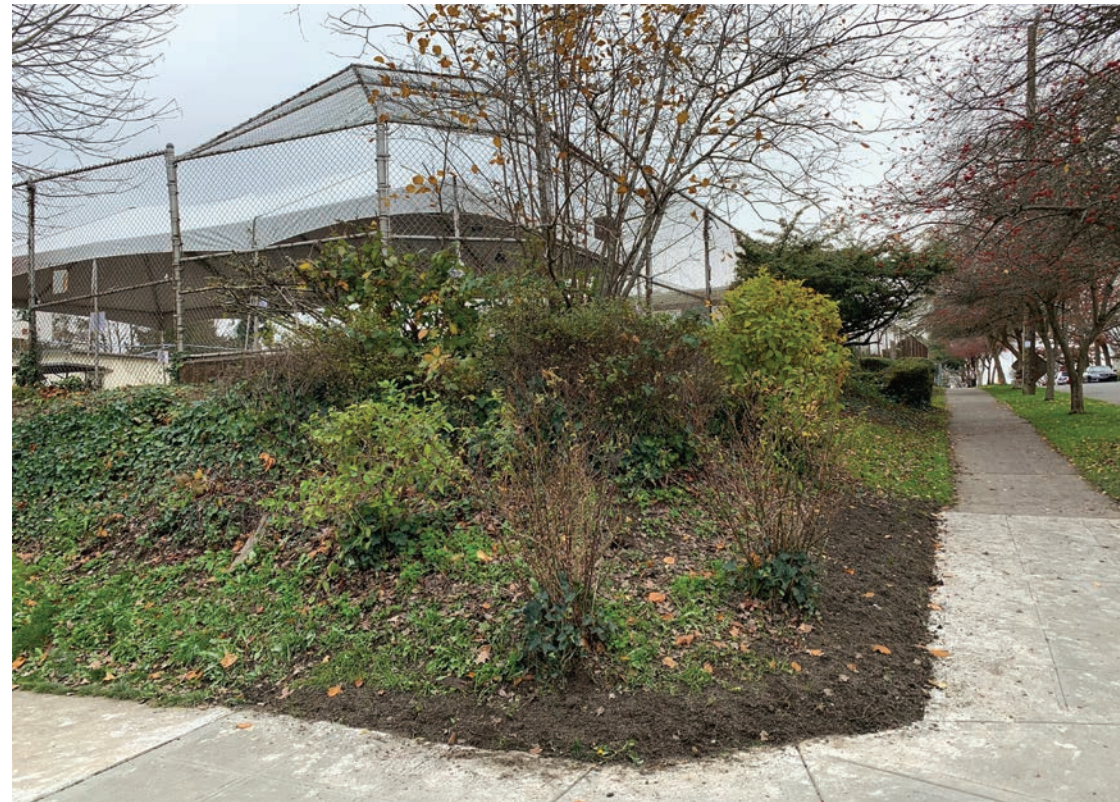
4. View of southwest corner at 20th Ave E and E McGraw

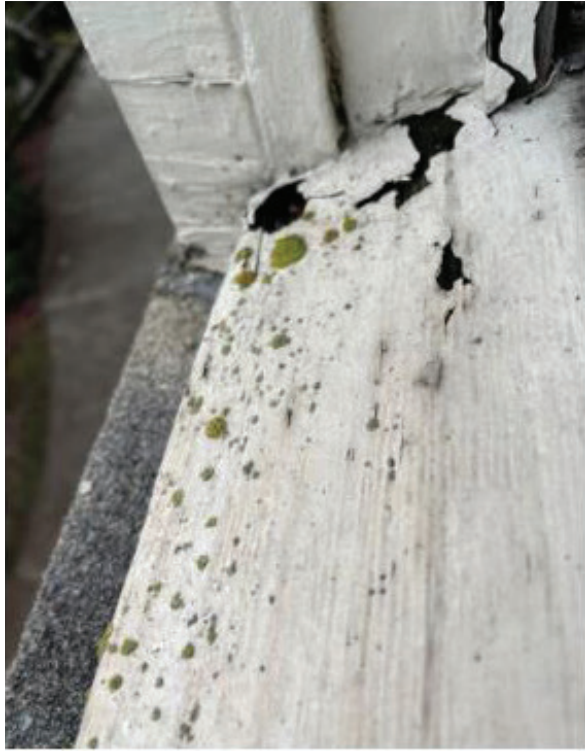
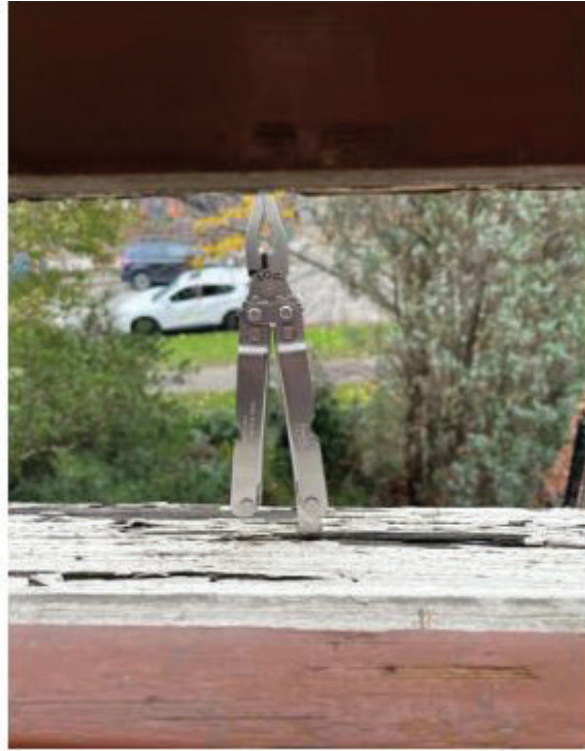
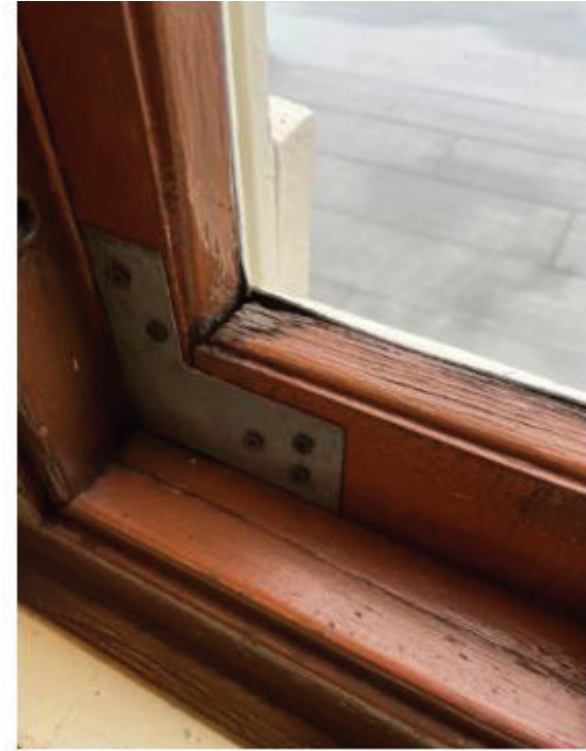
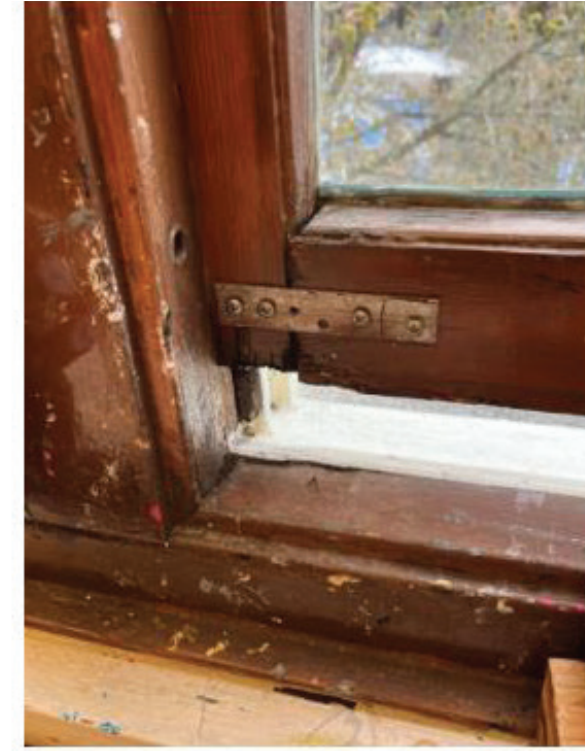
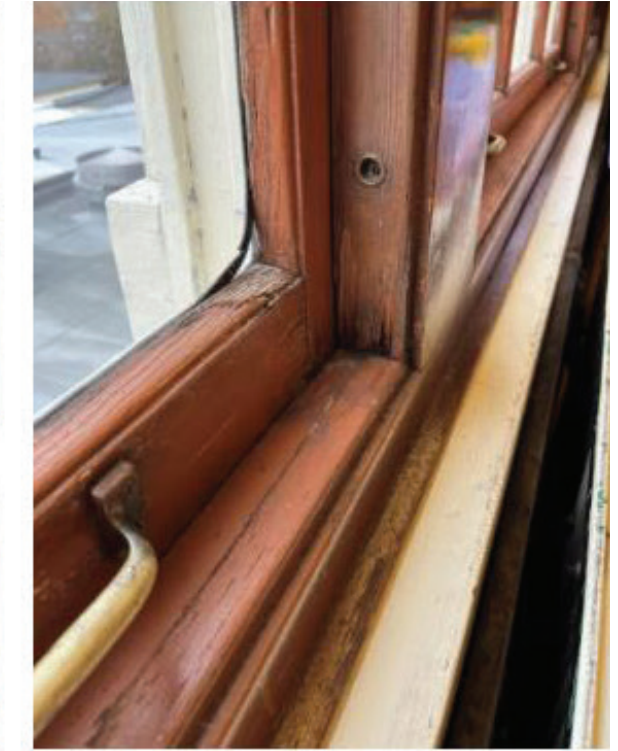
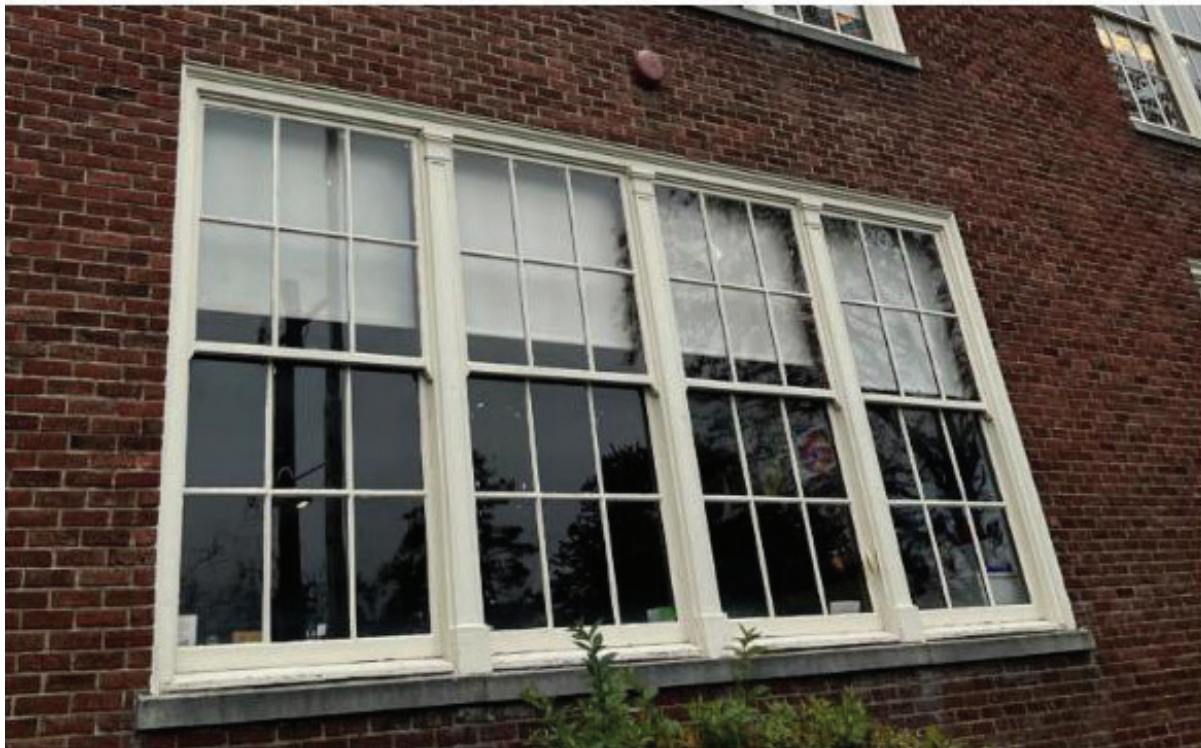
Typical deficiencies noted at windows:

- Dry rot at sills and lower jambs
- Separation at corner joints where bottom rails and stiles meet
- Failed glazing seals
- Water staining and raised grain at glass corners
- Cracking and splitting in sills

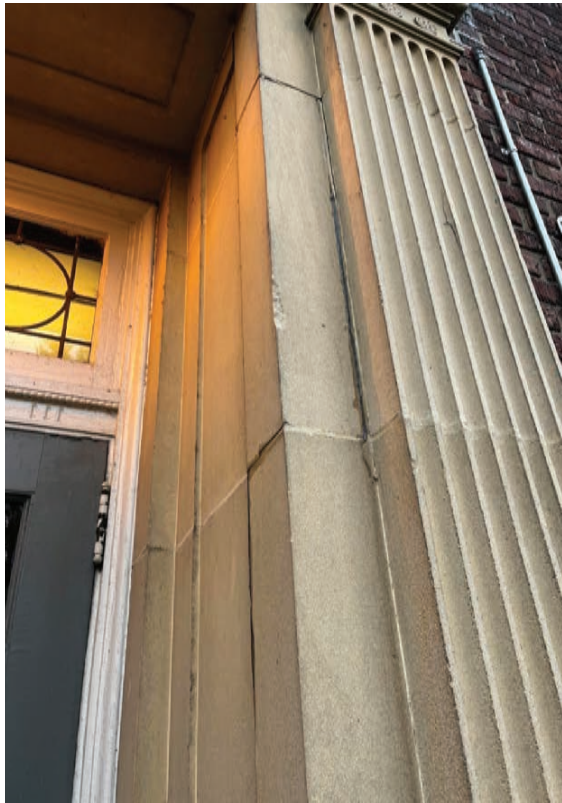
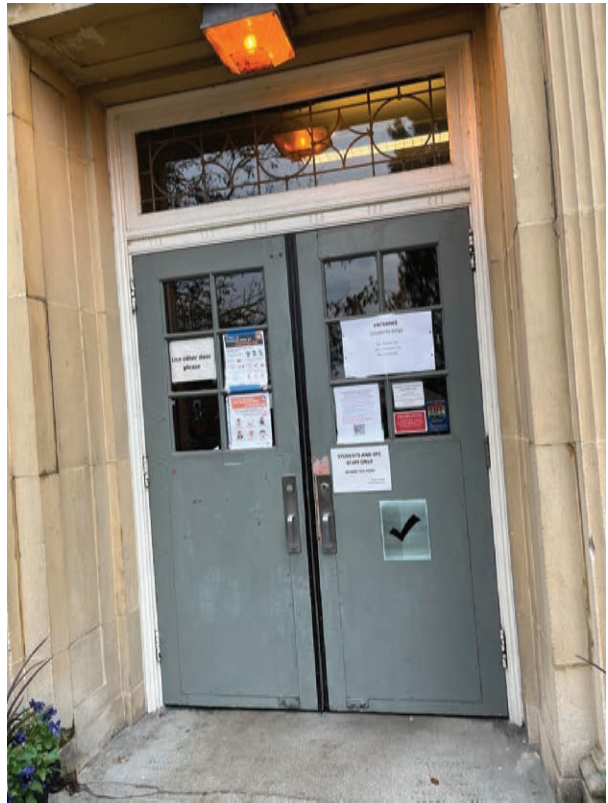
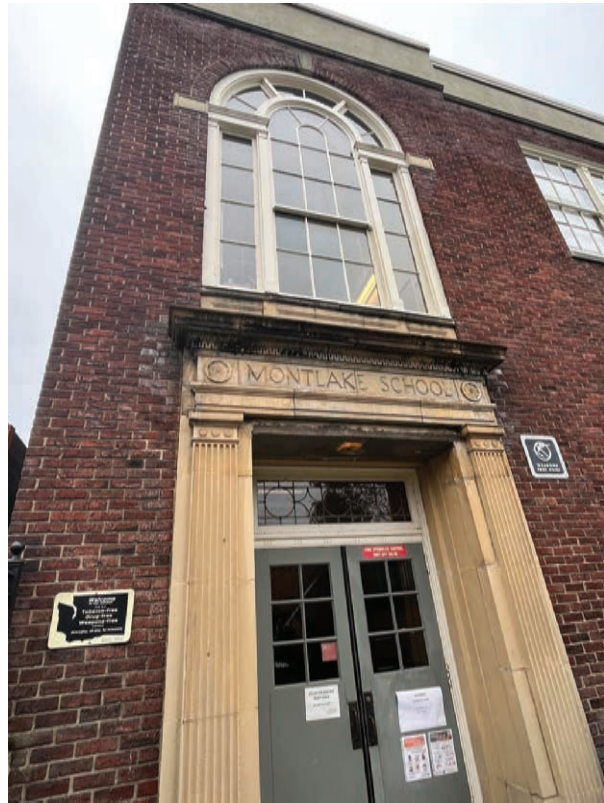
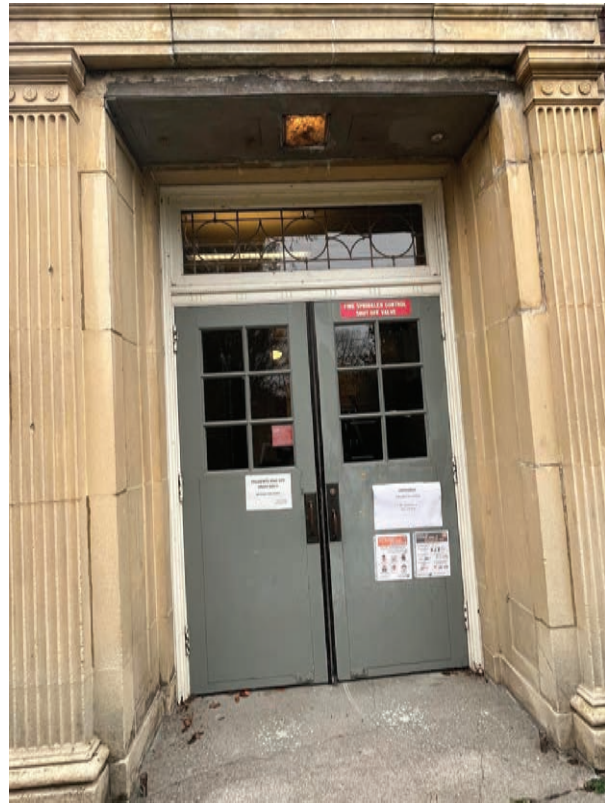
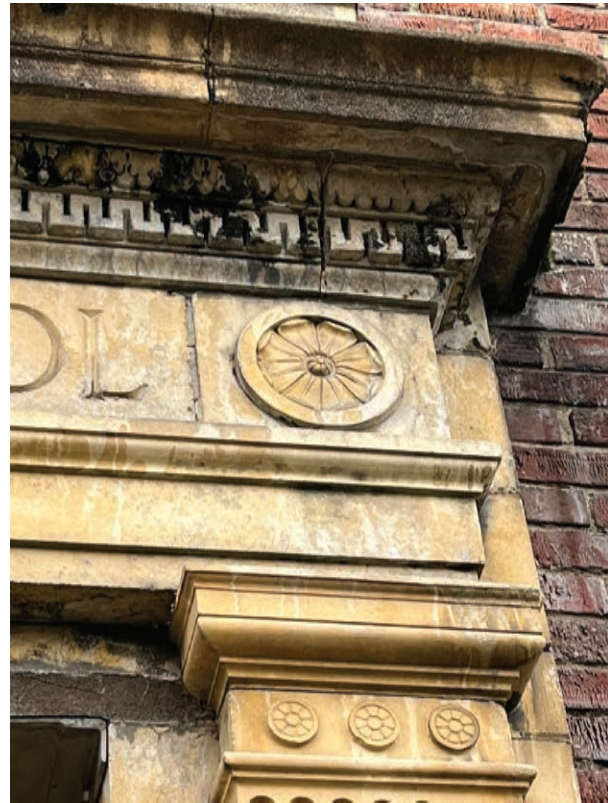
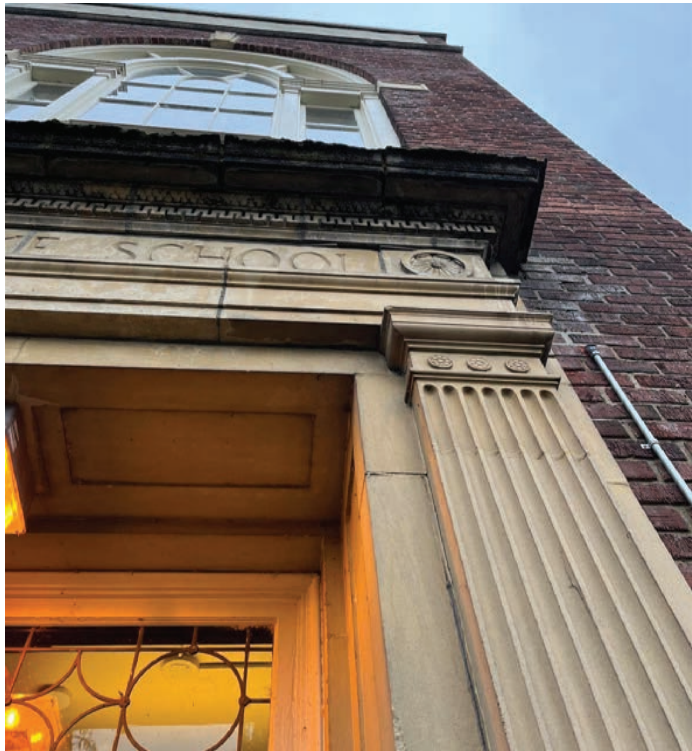
Deficiencies noted at cast stone:

- Severe discoloration at the projecting cornice above the entablature and significant water damage (cracking, spalling, staining) at the underside of those units. Water stains streaked down the adjacent vertical elements
- Water damage at the underside of the soffit panels. Soffit panels at the southeast entry have been replaced by a galvanized steel sheet (likely due to water damage)
- Vertical units at the pilasters and jambs of the surround are in fair conditions, but are in need of pointing

1. Cleaning - Warm water rinse, followed by a mild detergent wash with a nylon bristle brush and another warm water rinse.
2. Replacement - Custom cast concrete replica units at severely deteriorated units
3. Repair - Patching mortar (Cathedral Stone) to repair minor cracks and spalls
4. Cover - Recommend adding a standing seam copper cap at the top of the projecting cornice piece to assist in shedding water
5. Coating - Recommend painting all of the cast stone with a breathable coating to decrease the porosity of the cast stone and prevent further deterioration

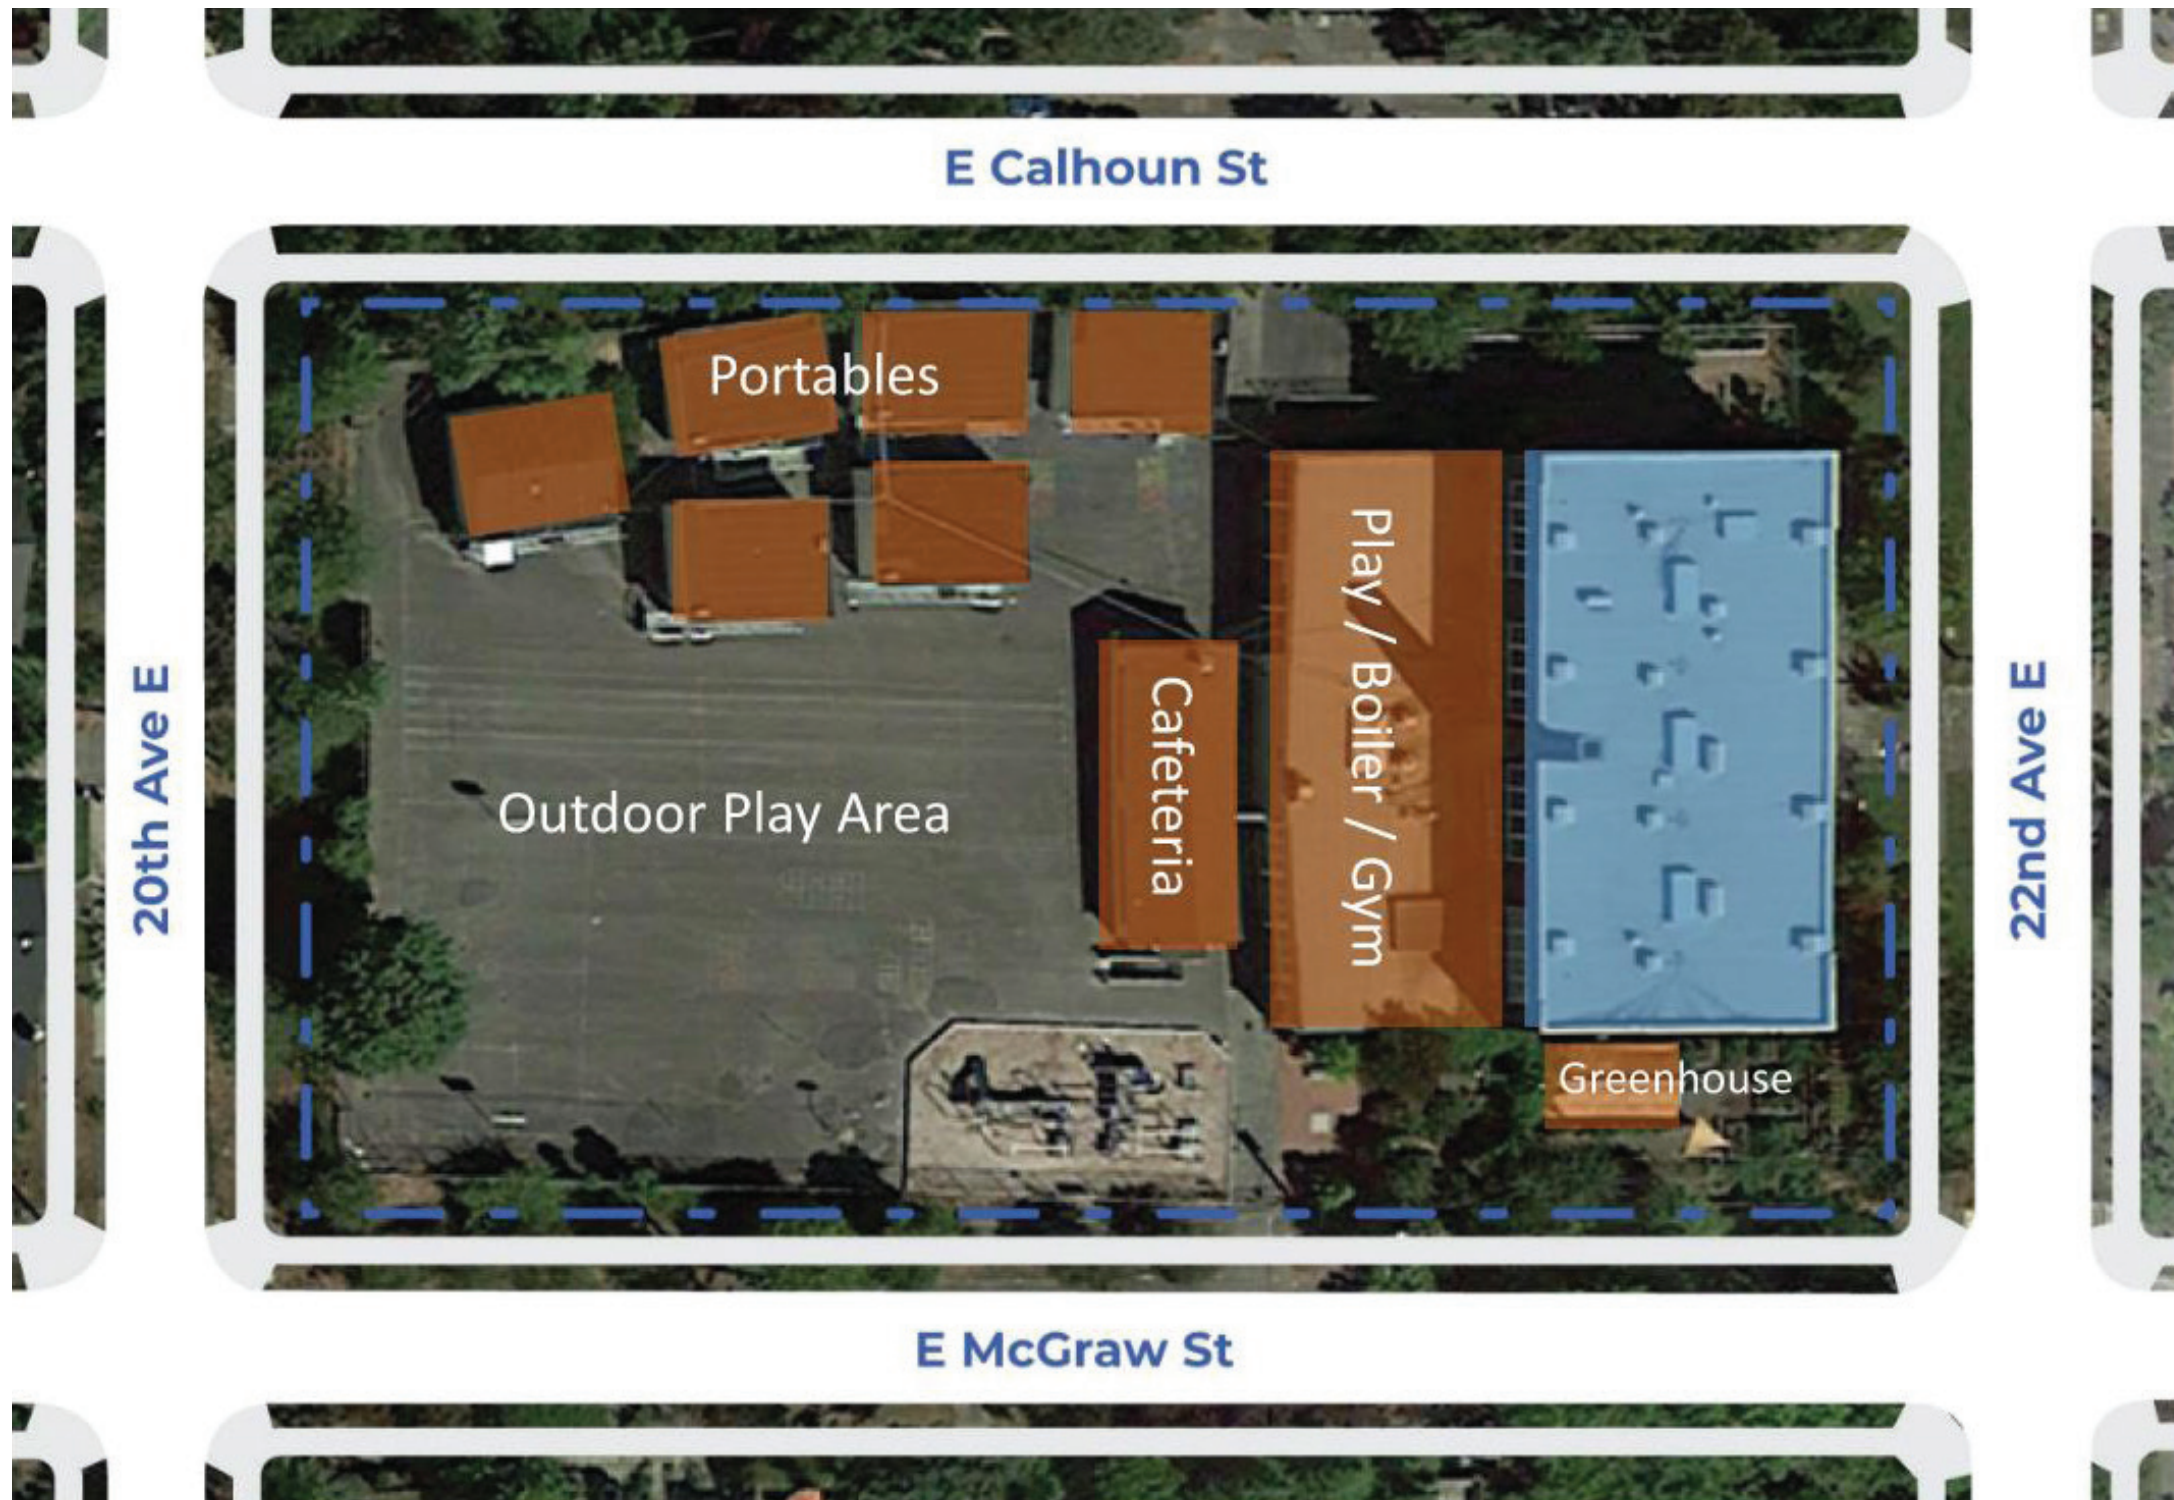
Landmarked Building To Remain

Proposed For Demo

1) Portables And Cafeteria Building - Portables and cafeteria building are not designated as landmark features. The portables were never intended as permanent site elements. Cafeteria and portables must be removed to accommodate educational program.

2) Covered Play/Boiler/Gym - This one story wood framed piece located at the rear of the existing building is part of the original construction and is included as a landmarked feature of the building, however, it is proposed for demolition as necessitated to accommodate educational program and to resolve accessibility issues with the original building. The Montlake site is one of the smallest in the district and removal of the single-story portion allows for more efficient use of the site to accommodate the required program elements. (Cont. Next page)

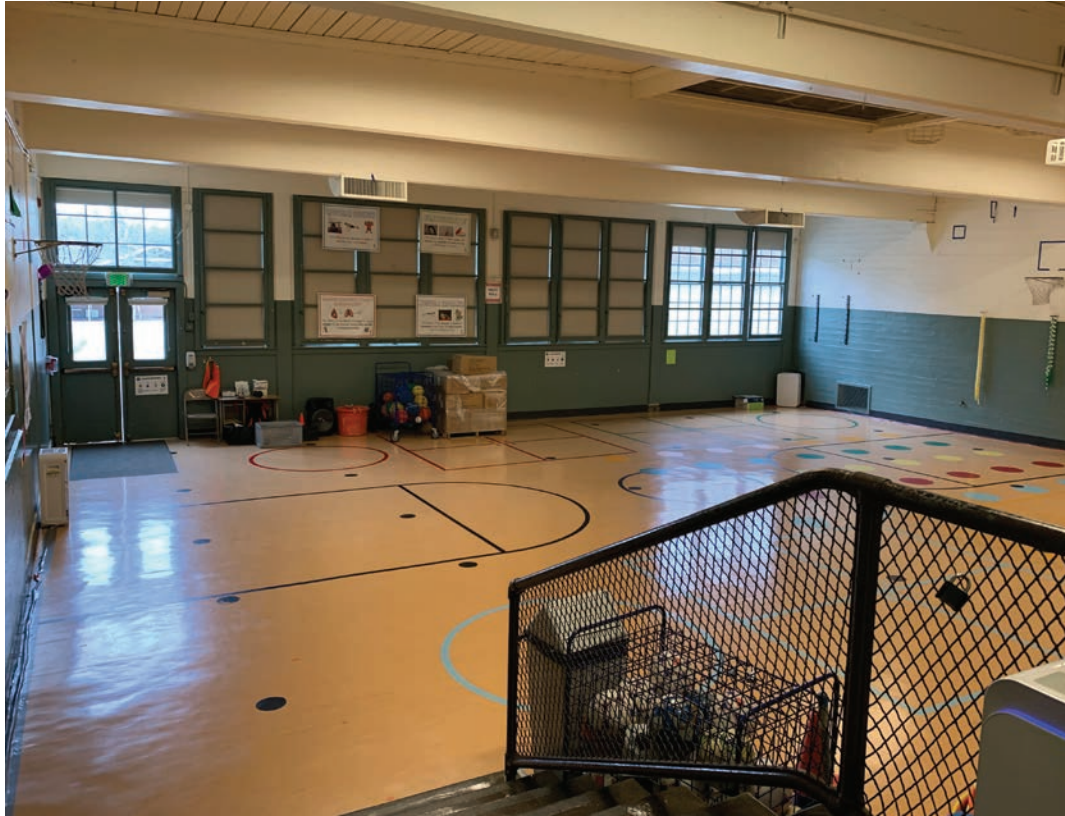
1. Interior view of existing gymnasium from top of stairs

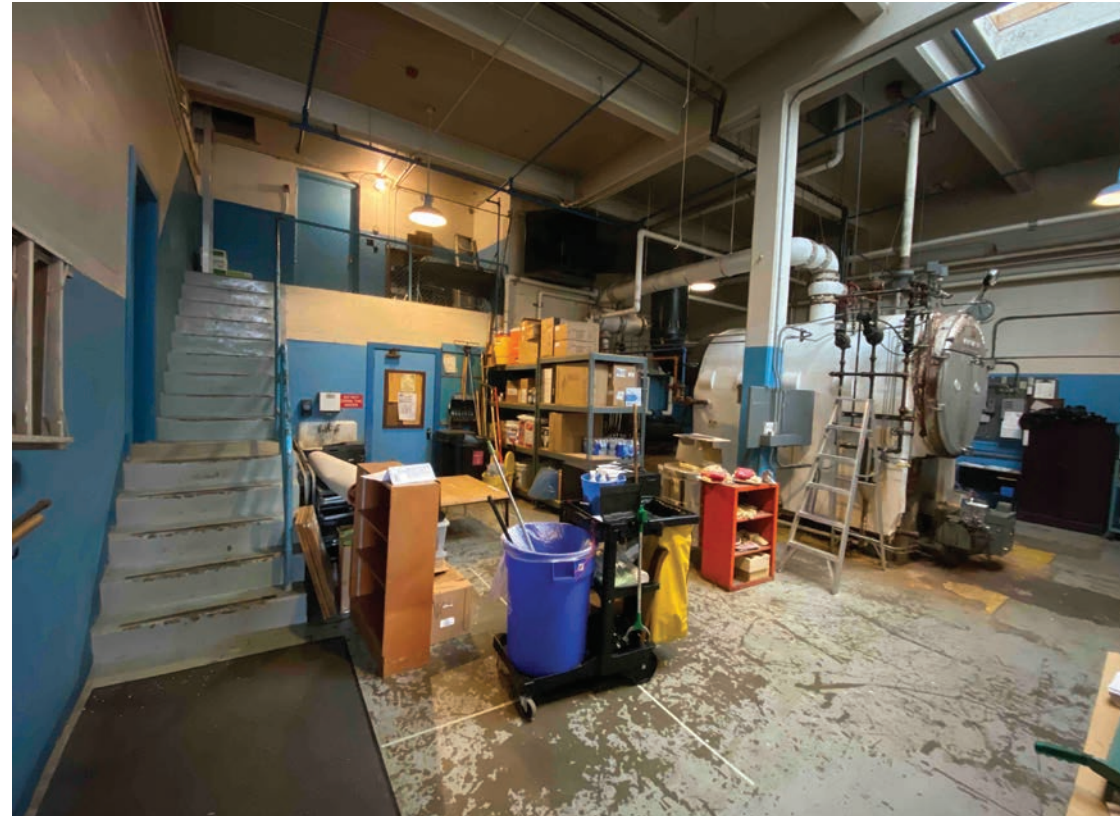
2. Interior view of existing boiler room from bottom of stairs

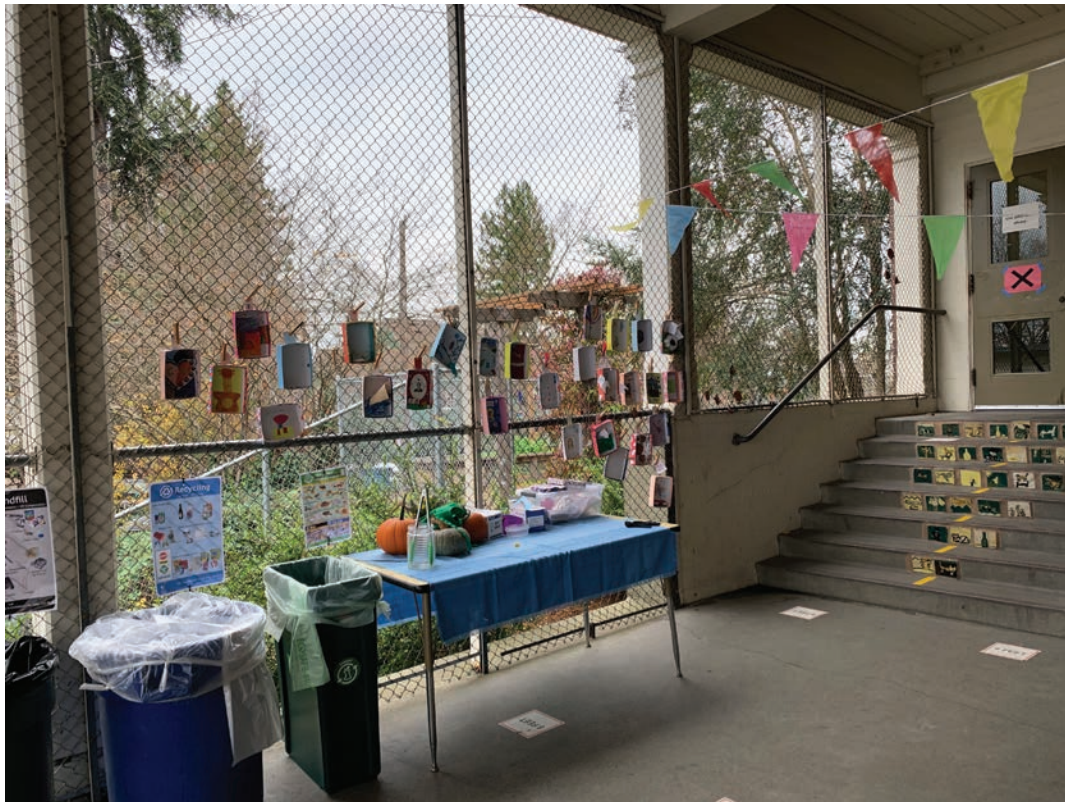
3. Interior view of covered play area from bottom of stairs to building

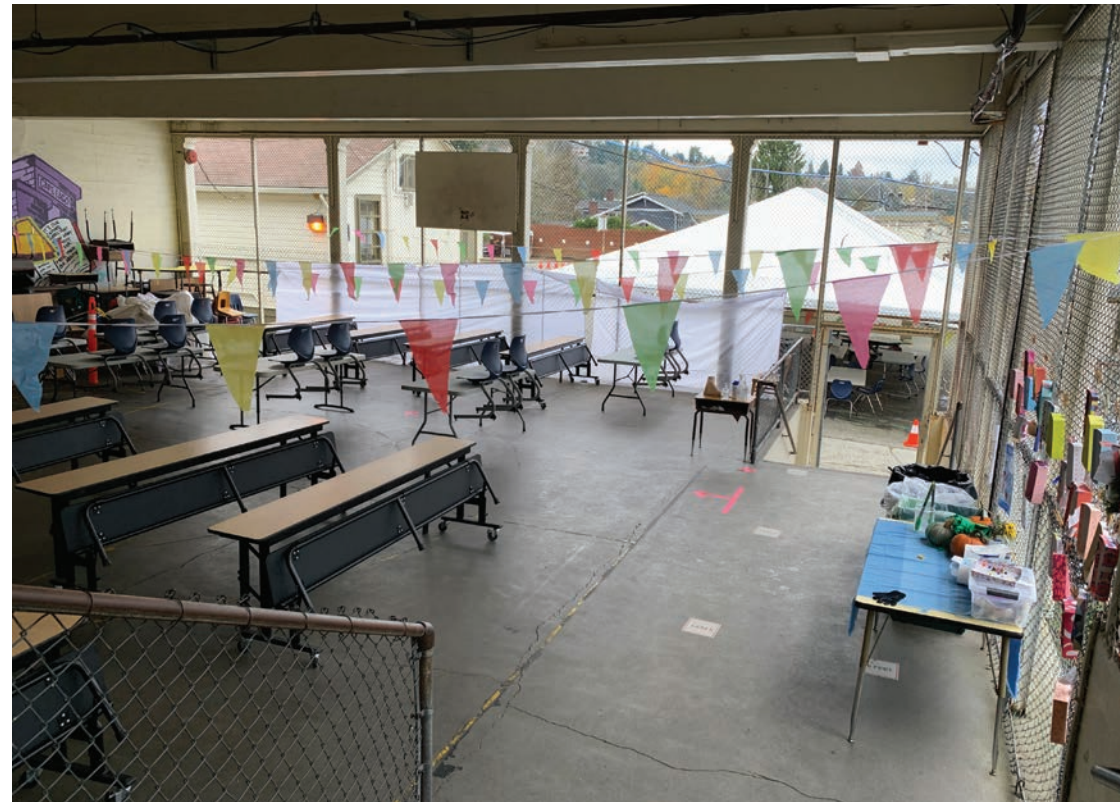
4. Interior view of covered play showing additional stairs down to site level

Floor levels for the Covered Play, Boiler and Gymnasium do not align with the site nor the building floor levels making these spaces inaccessible to students or staff with disabilities.

1. Current gymnasium is approx 1/3 of the district standard size and is only accessible to the building via stairs
2. Boiler room is undersized for current equipment needs and does not have a door to the exterior to provide safe access for maintenance staff to move supplies or equipment
3. Covered play is only accessible from the building via stairs
4. Covered play area is only accessible to the adjacent site via stairs

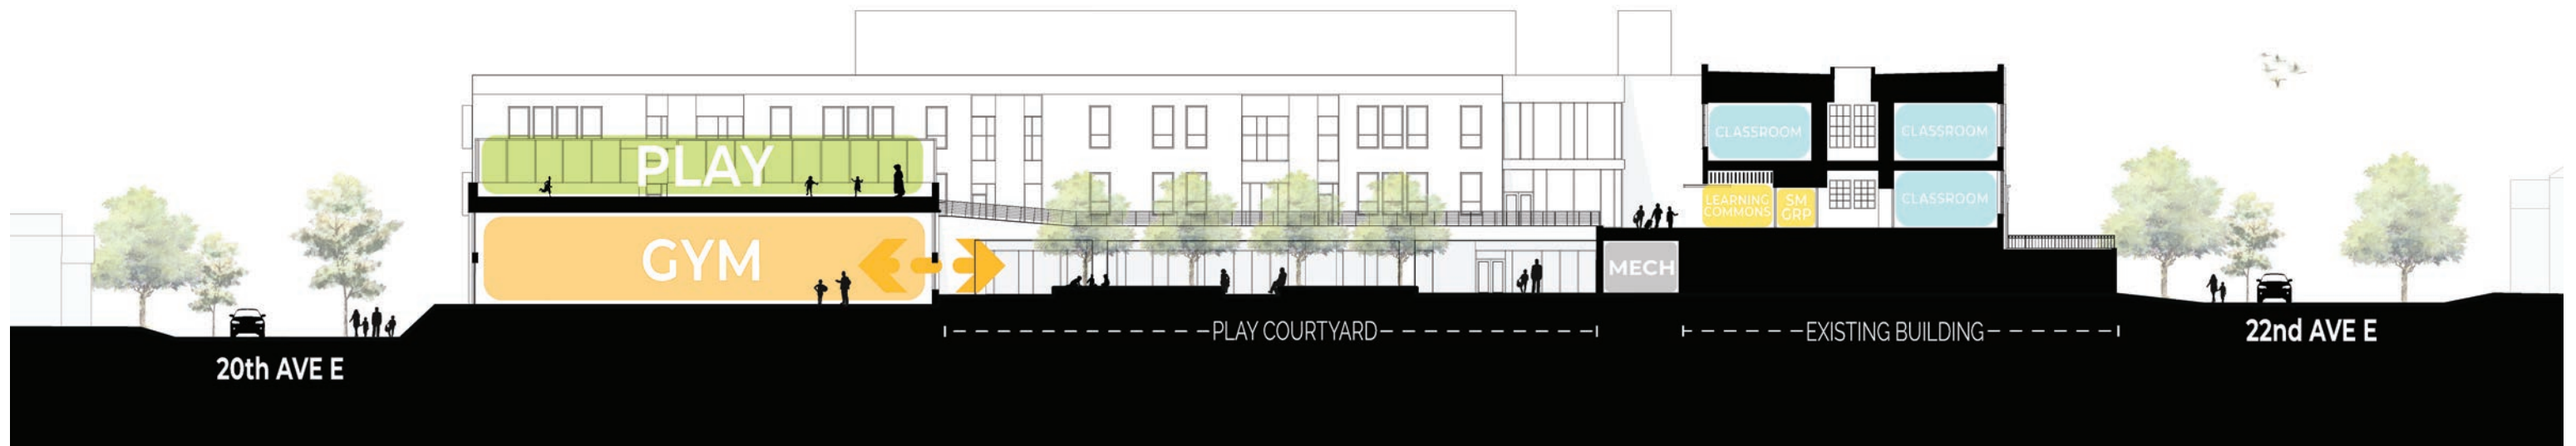
East to west site section

By working with the site slope, the design team is proposing to create a new courtyard level to the addition that sits below the level of the historic building ground floor. This courtyard level allows the team to limit the height of the new addition to align with the existing historic building parapet, while still being able to accommodate the necessary educational program elements. Placement of the mechanical penthouse is intentionally located to minimize visibility from the pedestrian right-of-way.
