MONTLAKE ELEMENTARY SCHOOL

SEATTLE PUBLIC SCHOOLS

**CERTIFICATE OF APPROVAL PACKET FOR SEATTLE LANDMARKS
PRESERVATION BOARD
SUBMITTED MARCH 10, 2023**

Modernization of and addition to the existing landmarked Montlake Elementary School on the same site, removal of all out-buildings and a reconfiguration of the school grounds.

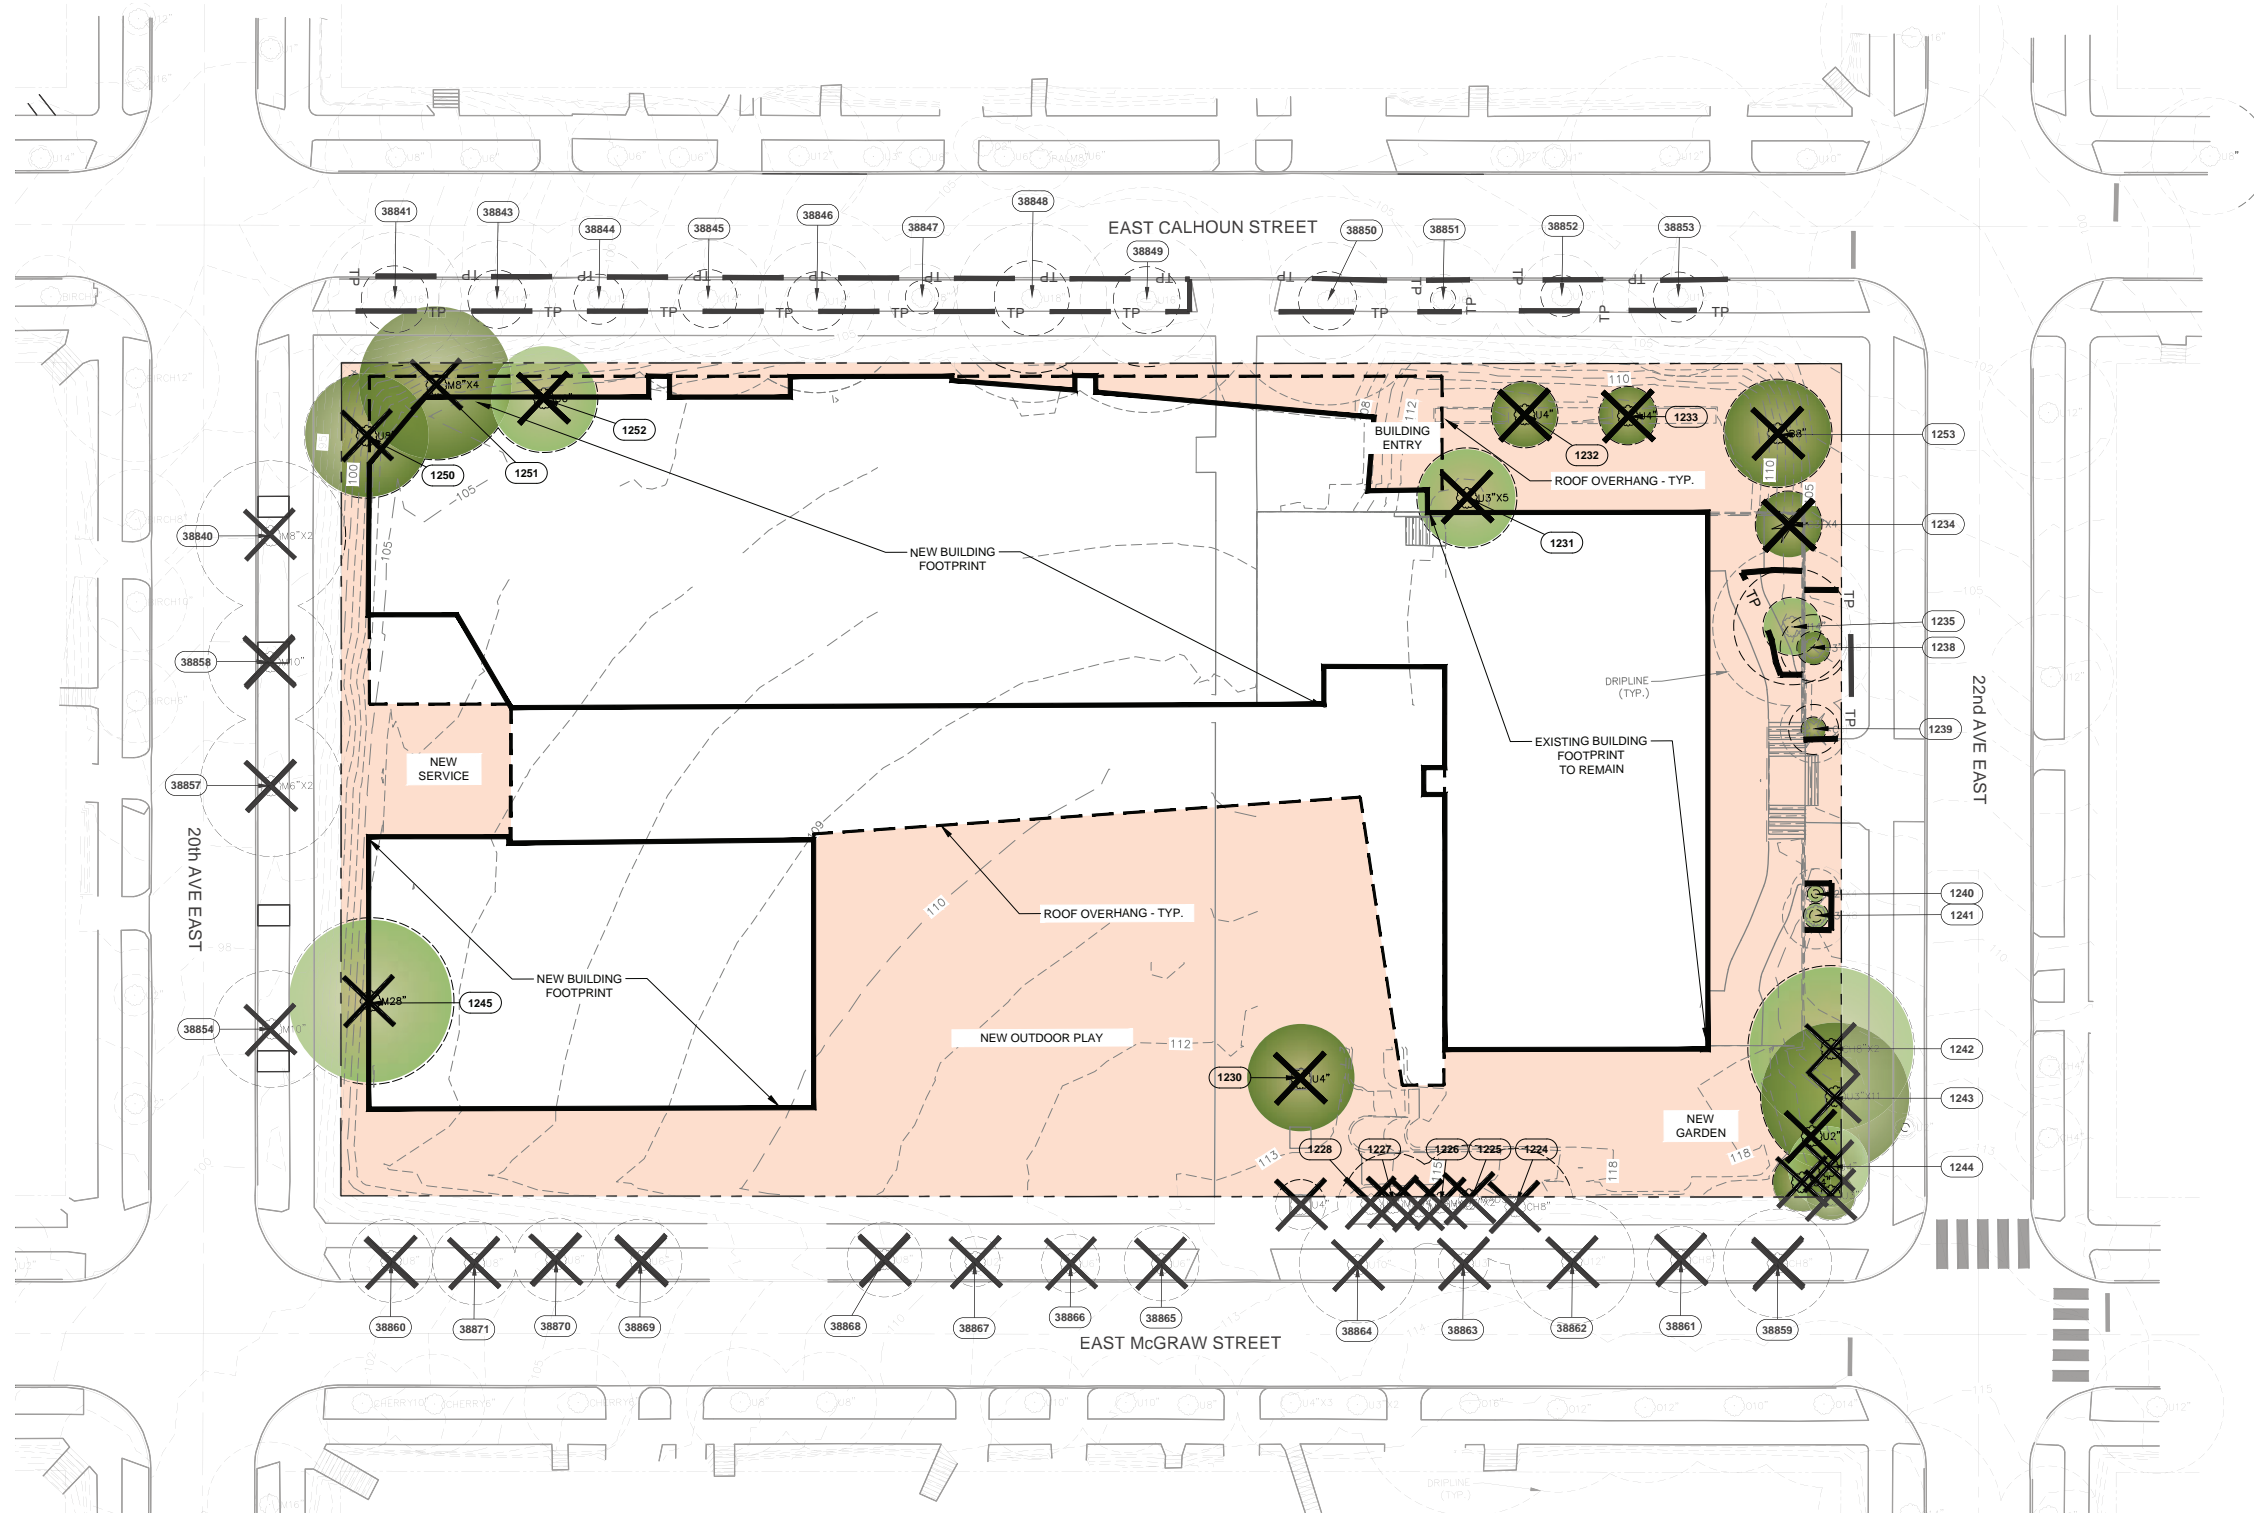
DEMO LANDSCAPE PLAN

- PROPERTY LINE
- TP TREE PROTECTION FENCE
- LIMIT OF WORK LINE
- CONTOURS - EXISTING
- EXISTING TREE TO BE REMOVED (SEE TREE INVENTORY FOR TREES TO BE SALVAGED AND/OR TRANSPLANTED ON SITE)
- EXISTING TREE NUMBER
- EXISTING TREE OUTER CRITICAL ROOT ZONE (DRIPLINE)
- EXISTING TREE INNER CRITICAL ROOT ZONE (1/2 DRIPLINE)
- 6" DEPTH ARBORIST CHIPS OR SITE GENERATED WOOD CHIPS FROM TREE REMOVAL OVER CRITICAL ROOT ZONE
- SPECIAL CONSTRUCTION REQUIREMENTS SEE NOTES CERTIFIED ARBORIST SHALL OBSERVE WORK WITHIN DRIPLINE OUTSIDE OF TREE PROTECTION FENCING

3. SEE SHEET TP1.03 FOR INVENTORY OF EXISTING TREES.
4. REMOVAL AND REPLACEMENT OF TREES WITHIN RIGHT-OF-WAY ACCORDING TO CITY OF SEATTLE REQUIREMENTS - PART OF THE STREET IMPROVEMENT PERMIT (SIP) REF: SUSIP 486.

9. SEE SPECIFICATION SECTION 01 56 39 FOR TREE TRUNK HARVESTING/SALVAGE REQUIREMENTS.
10. CLEAR ALL UNDERSTORY VEGETATION WITHIN TREE PROTECTION AREAS PRIOR TO INSTALLATION OF TREE PROTECTION MULCH. REMOVE ALL INVASIVE SHRUBS AND VINES INCLUDING BUT NOT LIMITED TO BLACKBERRY, HOLLY, AND IVY. REMOVAL SHALL BE BY HAND WITHIN ROOT PROTECTION AREAS. REMOVE ALL ROOTS OF INVASIVE PLANTS.

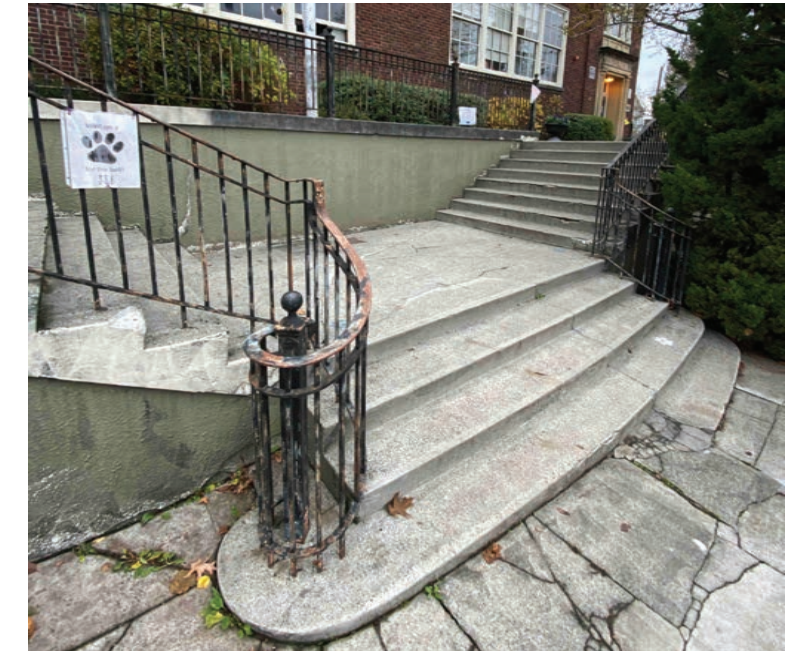
View of existing historic railing at east facade entry

1. 3" SQUARE POST
2. 1-3/4" CHANNEL RAIL
3. 1" SQUARE PICKET
4. BRACKETS
5. EXISTING ORNAMENTAL FENCE TO REMAIN AND TO BE PROTECTED.

NOTE:
ALL PARTS TO BE SHOP POWDERCOATED PER SPECIFICATIONS, WITH NO BURRS OR SHARP EDGES. COLOR BLACK.
WELD TO BE TYPE II QUALITY PER NAAMM

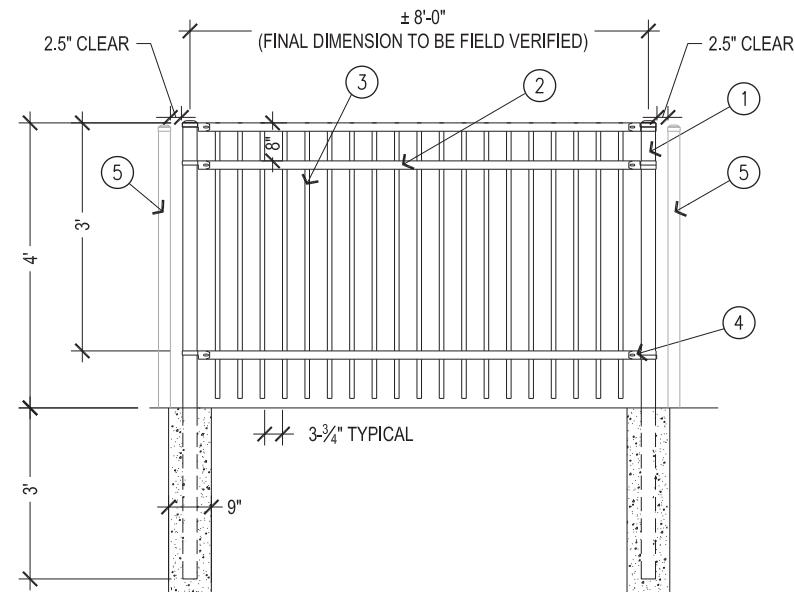
Proposed Ornamental fencing at areas noted: Ameristar Montage II

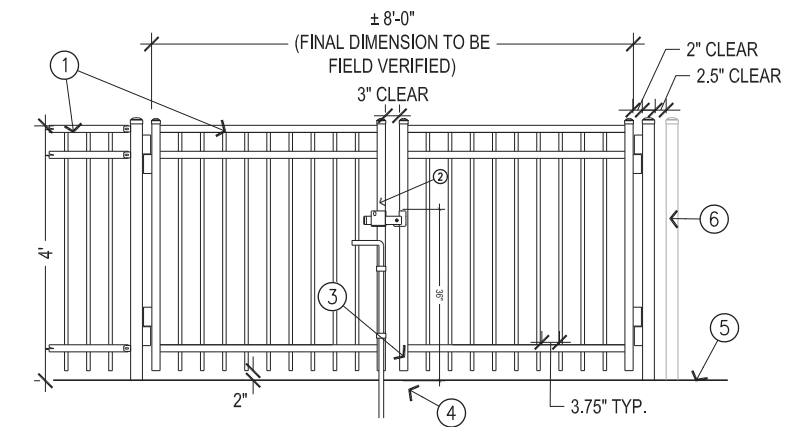
1. PICKET FENCE AND GATE, SEE SEC 323119
2. GATE LATCH, ATTACH PER MANUF RECOMMENDATION
3. 1" DIA. CANE BOLT MOUNTED ON ORN. FENCE.
4. 1 1/2" I.D. STEEL PIPE CAST INTO CONC. PAVING.
5. FINISHED GRADE
6. EXISTING ORNAMENTAL FENCE TO REMAIN AND TO BE PROTECTED.

NOTE:
ALL PARTS TO BE HOT-DIPPED GALVANIZED PRIMED AND PAINTED, WITH NO BURRS OR SHARP EDGES.
WELD TO BE TYPE II QUALITY PER NAAMM

Proposed Ornamental gate at areas noted: Ameristar Montage II

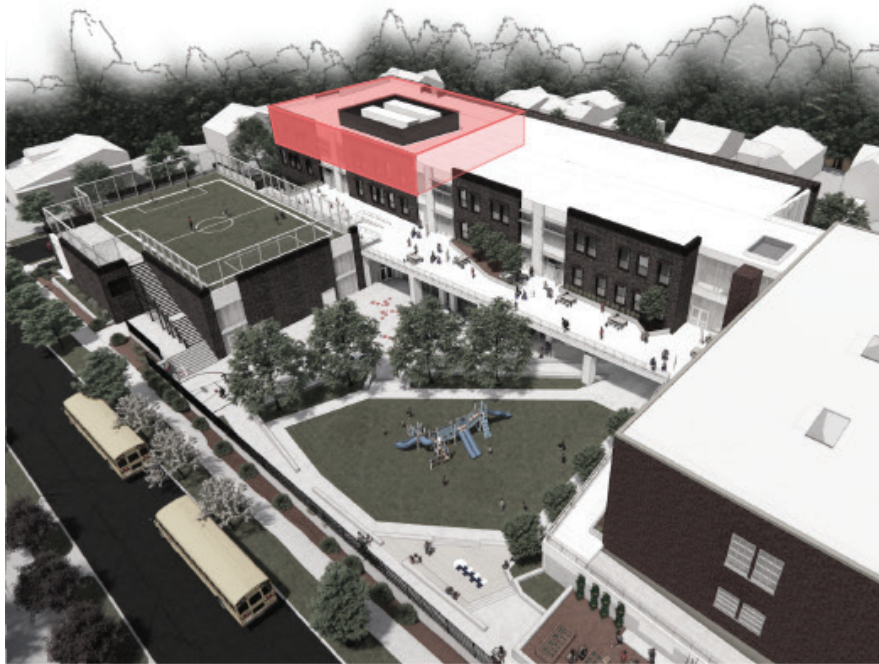
① PENTHOUSE LOCATED ON THIRD FLOOR

As part of the design process, the team studies alternate locations for the penthouse.

The above diagrams demonstrate the reduction of outdoor play area and indoor program, and daylight reductions that would be sacrificed if the penthouse equipment were placed within the main building footprint or on the ground level.

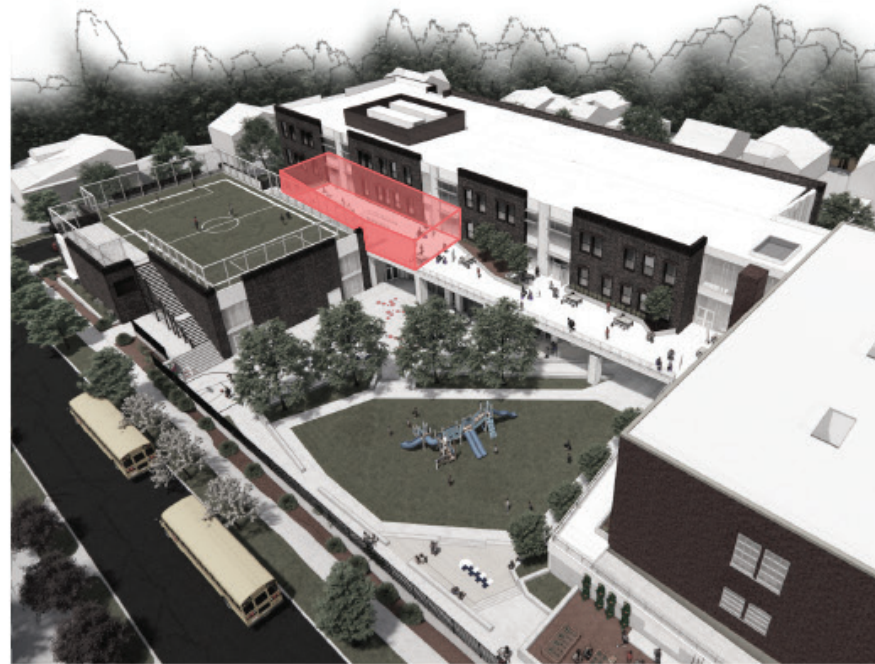
② PENTHOUSE LOCATED IN COURTYARD

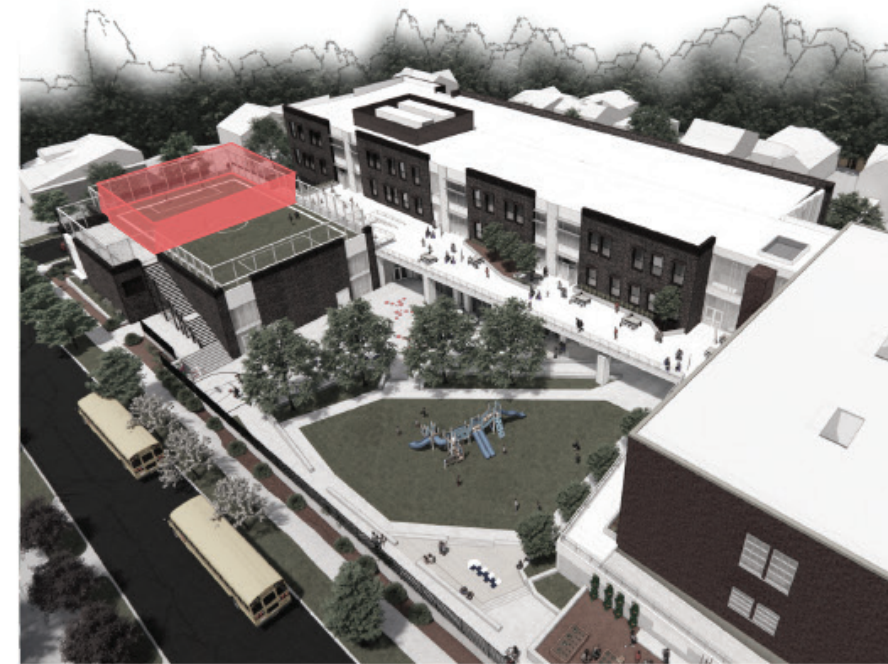
③ PENTHOUSE LOCATED ON GYM ROOFTOP

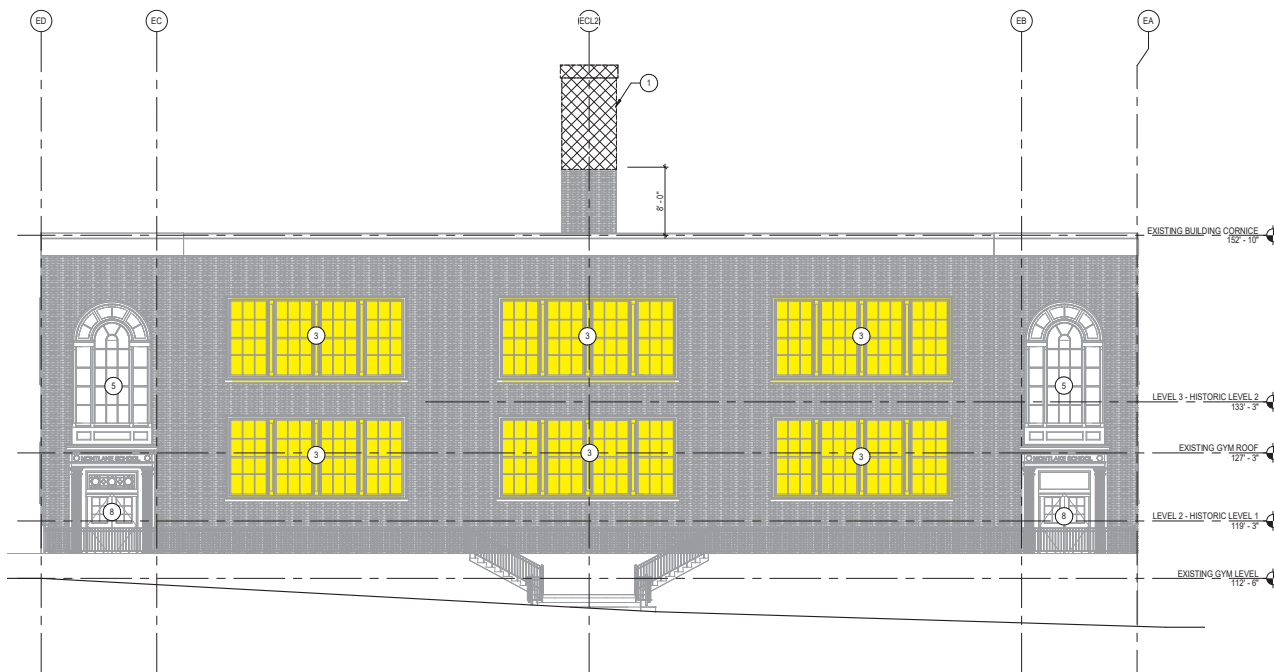
East Demo Elevation

DEMO ELEVATIONS HISTORIC FACADES

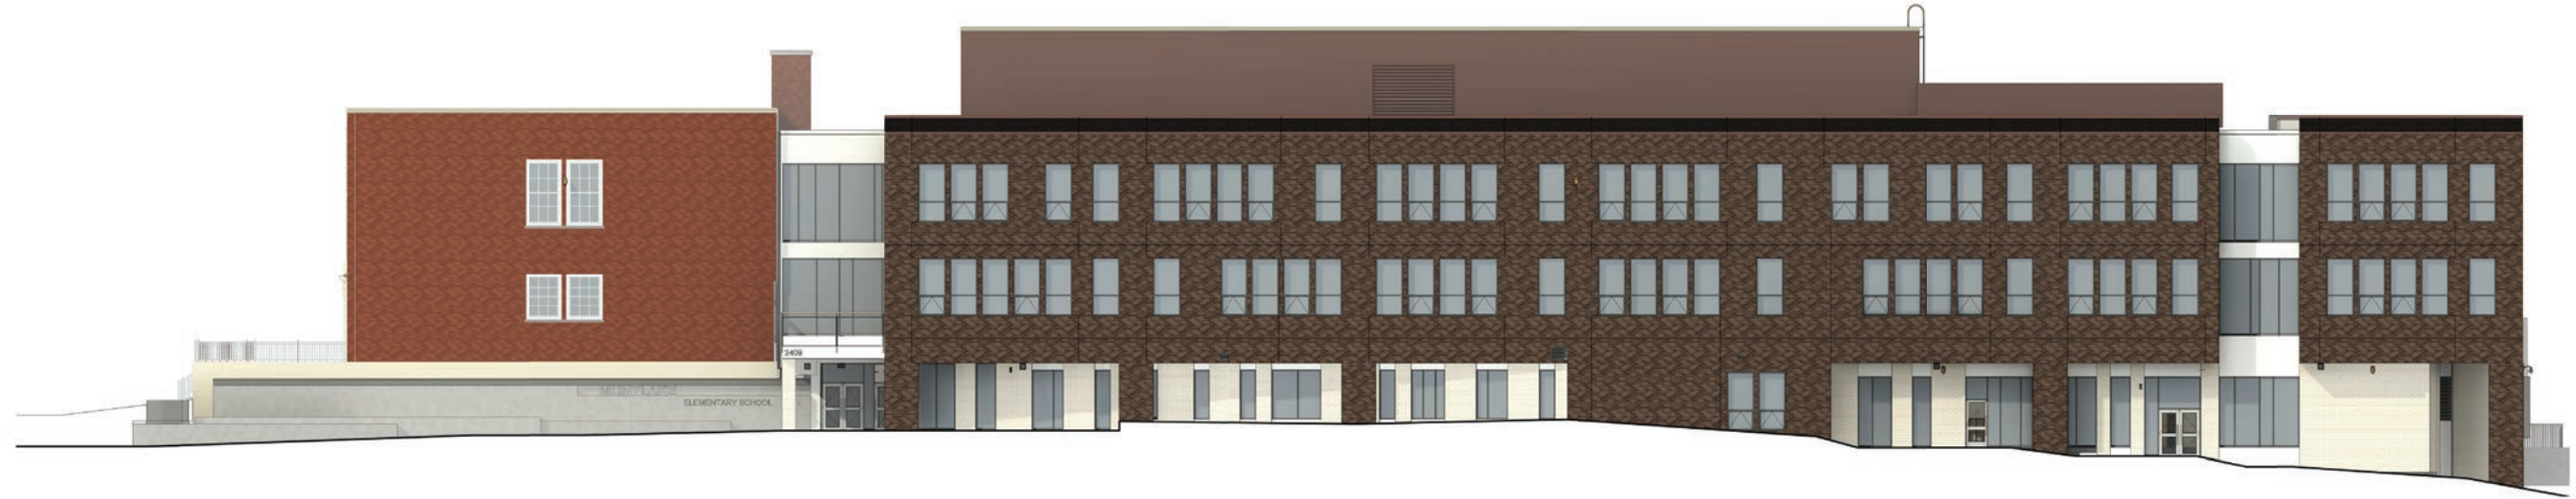
Proposed Overall North Elevation

BUILDING ELEVATIONS - MATERIAL CHARACTER

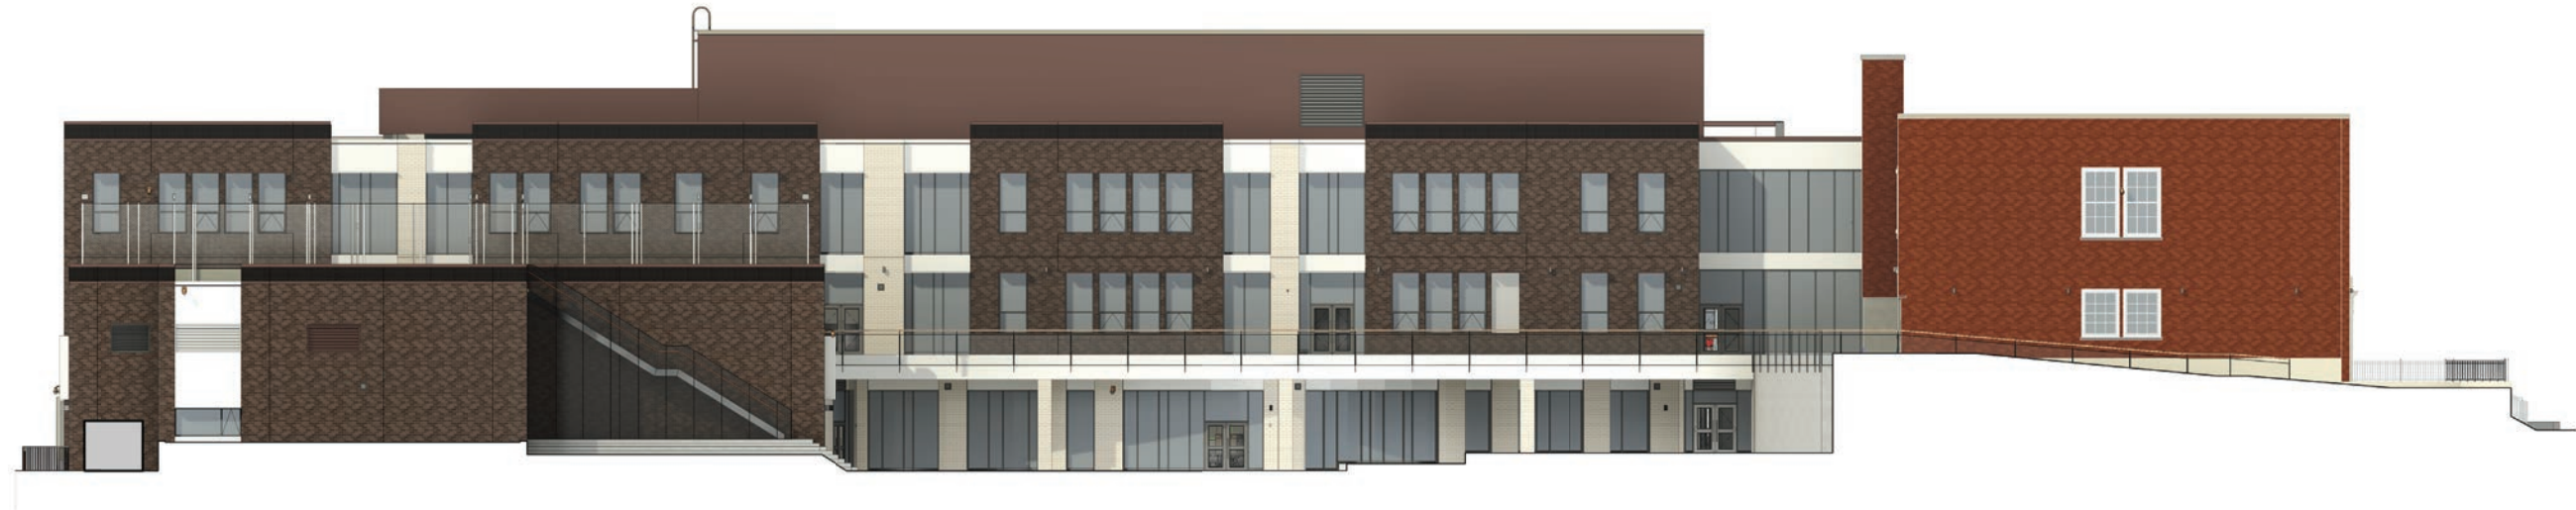
Proposed Overall South Elevation

BUILDING ELEVATIONS - MATERIAL CHARACTER

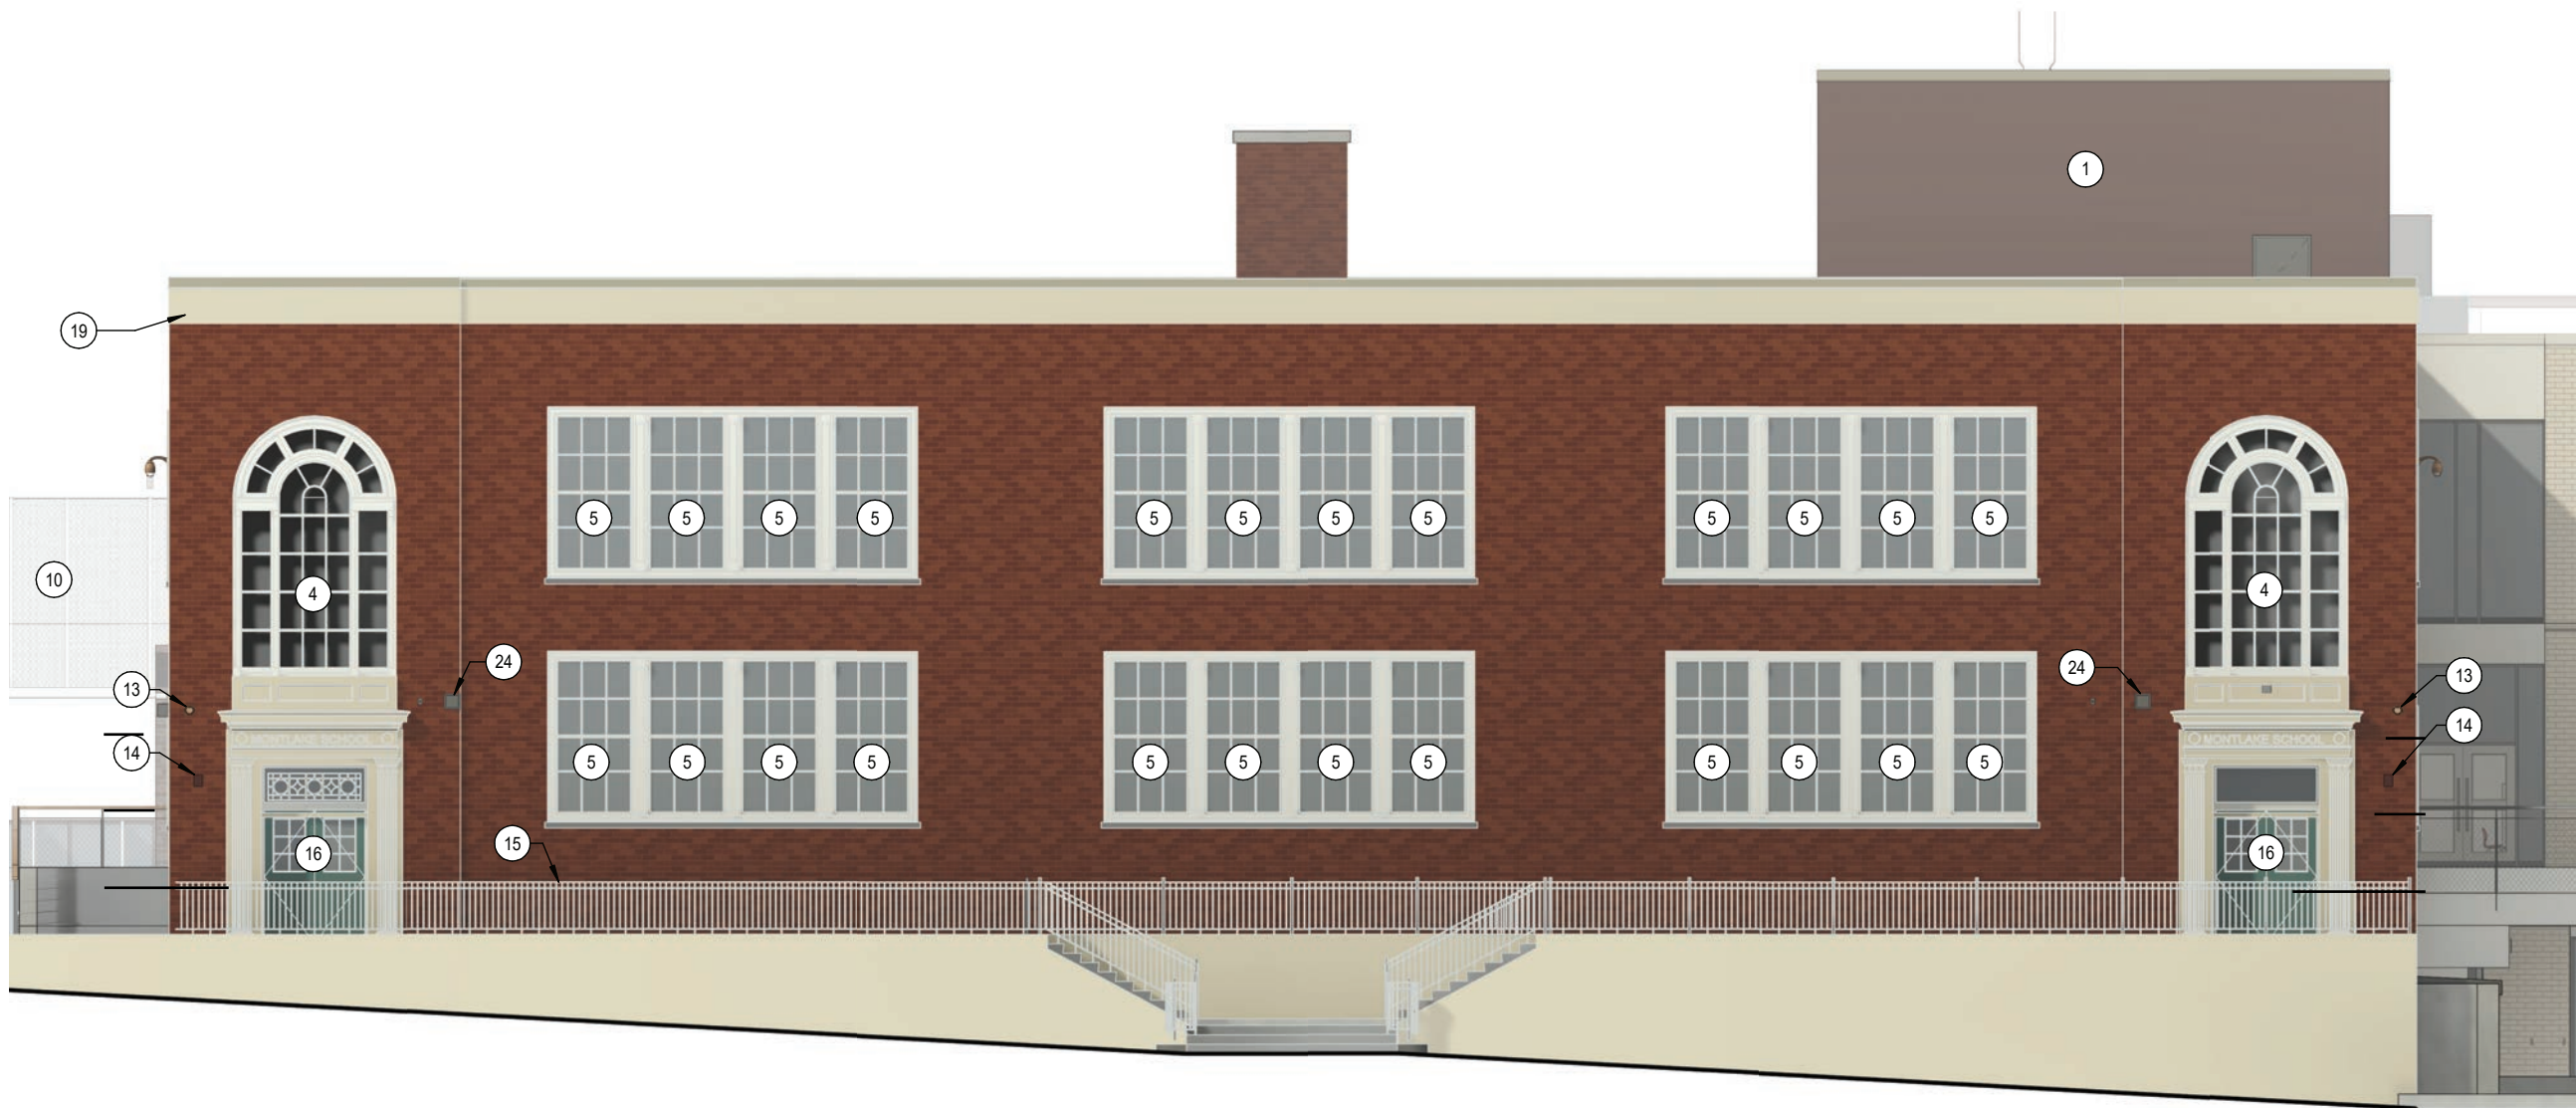
Enlarged Historic East Elevation View

ENLARGED PROPOSED BUILDING ELEVATION

- 4 WINDOW RESTORATION
- 5 SASH REPLACEMENT
- 6 FIBERGLASS WINDOW
- 7 CUT BENT PLATE
- 8 VERTICAL WINDOW SHADE
- 9 METAL MESH GUARDRAIL SYSTEM
- 10 CHAINLINK FENCE POSTS AND NETTING

- 16 REPAIR AND REPAINT EXISTING WOOD DOOR AND FRAME
- 17 MOBIL GARDEN SINK
- 18 EXISTING FACADE TO REMAIN. REFER TO PLANS FOR AREA OF WORK
- 19 EXISTING CORNICE TO REMAIN

- 20 HORIZONTAL MASONRY JOINT. REFER TO DETAIL 1E/A9.50
- 21 INFILL EXISTING CONCRETE WALL WITH CONCRETE
- 22 DRYER VENT - PAINT X-XX
- 23 EXHAUST VENT - PAINT X-XX

- 24 INTERCOM SPEAKER
- 25 ELECTRONIC READER BOARD

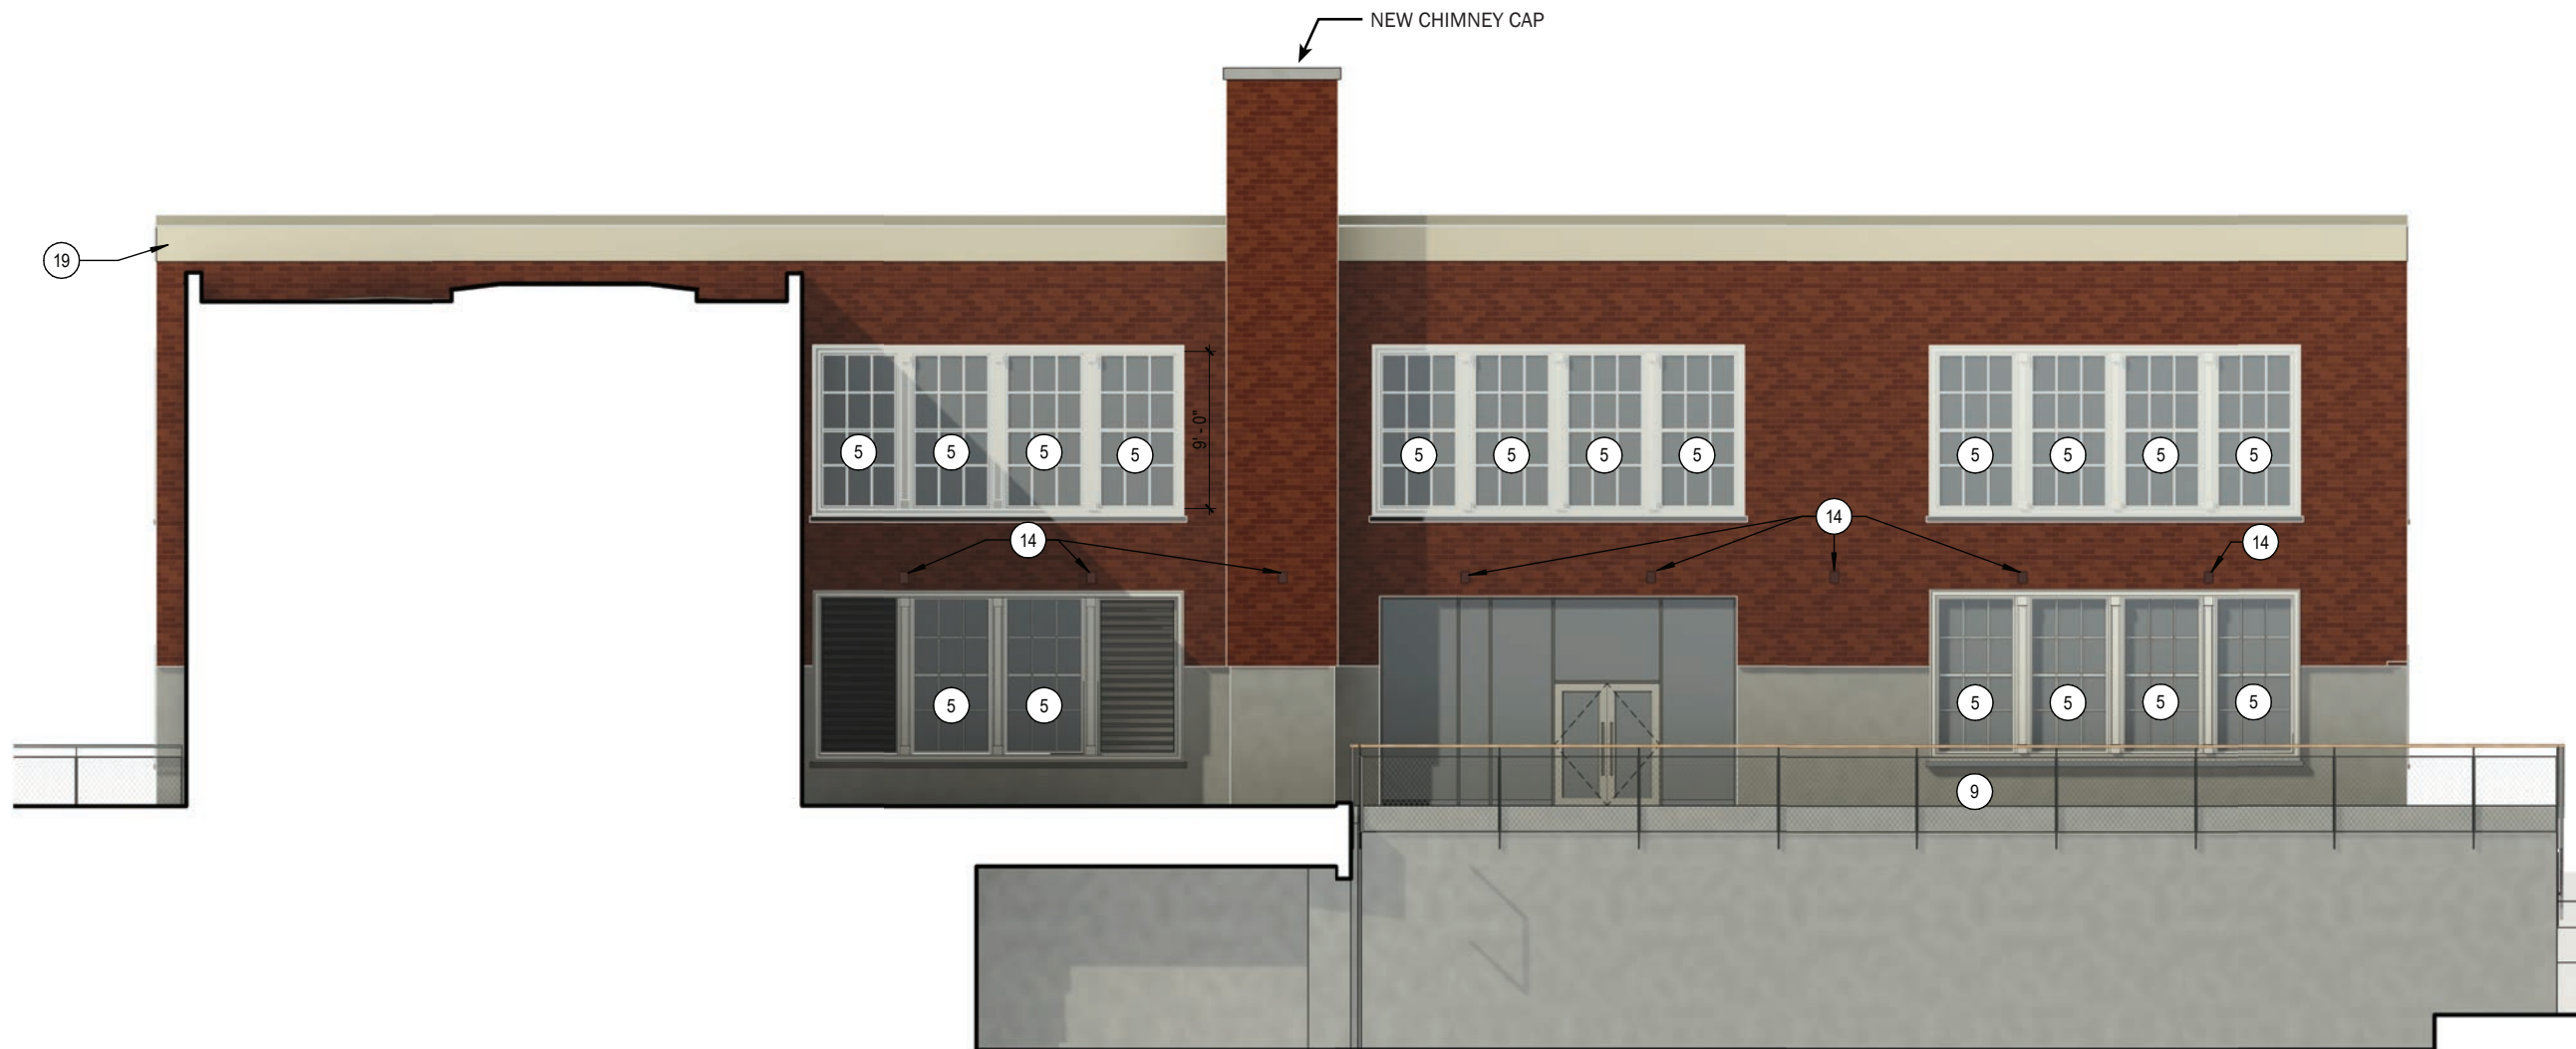
Enlarged Historic West Elevation View

ENLARGED PROPOSED BUILDING ELEVATION

- 4 WINDOW RESTORATION
- 5 SASH REPLACEMENT
- 6 FIBERGLASS WINDOW
- 7 CUT BENT PLATE
- 8 VERTICAL WINDOW SHADE
- 9 METAL MESH GUARDRAIL SYSTEM
- 10 CHAINLINK FENCE POSTS AND NETTING

- 16 REPAIR AND REPAINT EXISTING WOOD DOOR AND FRAME
- 17 MOBIL GARDEN SINK
- 18 EXISTING FACADE TO REMAIN. REFER TO PLANS FOR AREA OF WORK
- 19 EXISTING CORNICE TO REMAIN

- 20 HORIZONTAL MASONRY JOINT. REFER TO DETAIL 1E/A9.50
- 21 INFILL EXISTING CONCRETE WALL WITH CONCRETE
- 22 DRYER VENT - PAINT X-XX
- 23 EXHAUST VENT - PAINT X-XX

- 24 INTERCOM SPEAKER
- 25 ELECTRONIC READER BOARD

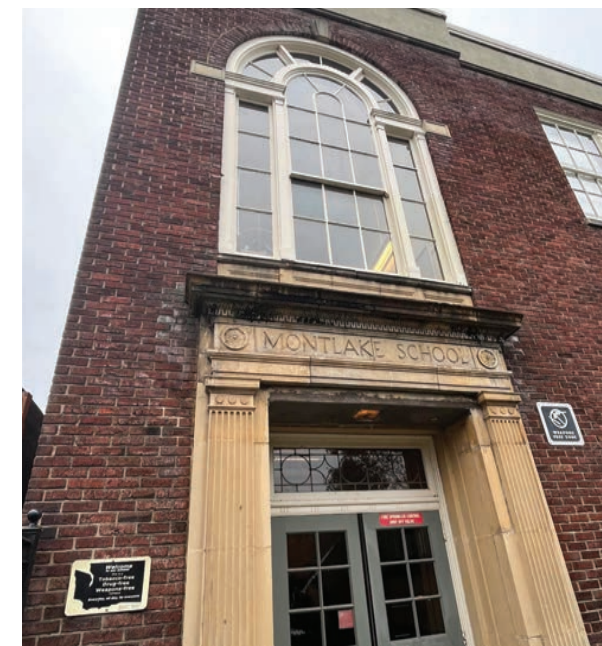
Southeast Entry Door

While the original drawings specified terra cotta, the original building was constructed using cast stone components for the ornamental pieces surrounding the main entries. Per the Landmark nomination, this was done to save cost. Because of the more porous nature of cast stone some of these pieces have not performed well. The design team is proposing the following treatments:

1. Cleaning - Warm water rinse, followed by a mild detergent wash with a nylon bristle brush and another warm water rinse.
2. Replacement - Custom cast concrete replica units at severely deteriorated units
3. Repair - Patching mortar (Cathedral Stone) to repair minor cracks and spalls
4. Cover - Recommend adding a standing seam copper cap at the top of the projecting cornice piece to assist in shedding water
5. Coating - Recommend painting all of the cast stone with a breathable coating to decrease the porosity of the cast stone and prevent further deterioration

- Severe discoloration at the projecting cornice above the entablature and significant water damage (cracking, spalling, staining) at the underside of those units. Water stains streaked down the adjacent vertical elements
- Water damage at the underside of the soffit panels. Soffit panels at the southeast entry have been replaced by a galvanized steel sheet (likely due to water damage)
- Vertical units at the pilasters and jambs of the surround are in fair conditions, but are in need of pointing

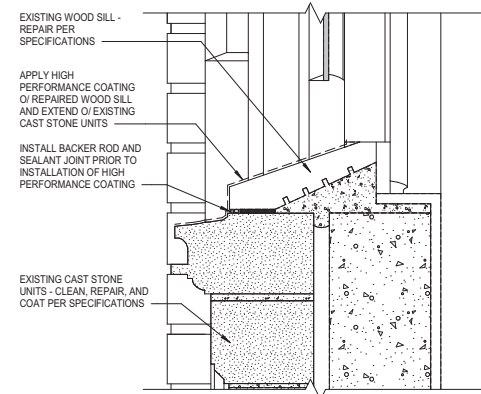
B. Detail at Arched Window Sill

Existing arched wood windows and all wood frames will be repaired using a combination of two-part epoxy and dutchman repair methods. Where wood elements are beyond repair, they will be replaced to match existing sizes and profiles. All wood will be painted to protect it.

- Dry rot at sills and lower jambs
- Separation at corner joints where bottom rails and stiles meet
- Failed glazing seals
- Water staining and raised grain at glass corners
- Cracking and splitting in sills

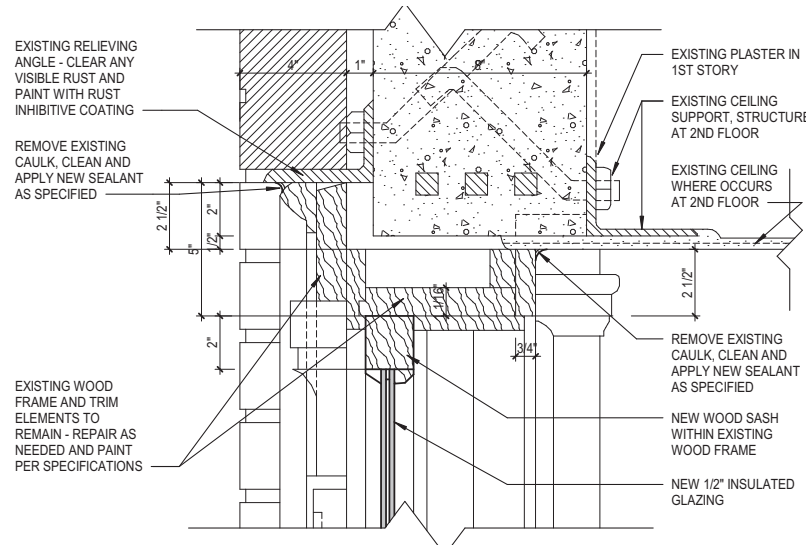
1. Detail through Window Head

HISTORIC WINDOW REPLACEMENT DETAILS

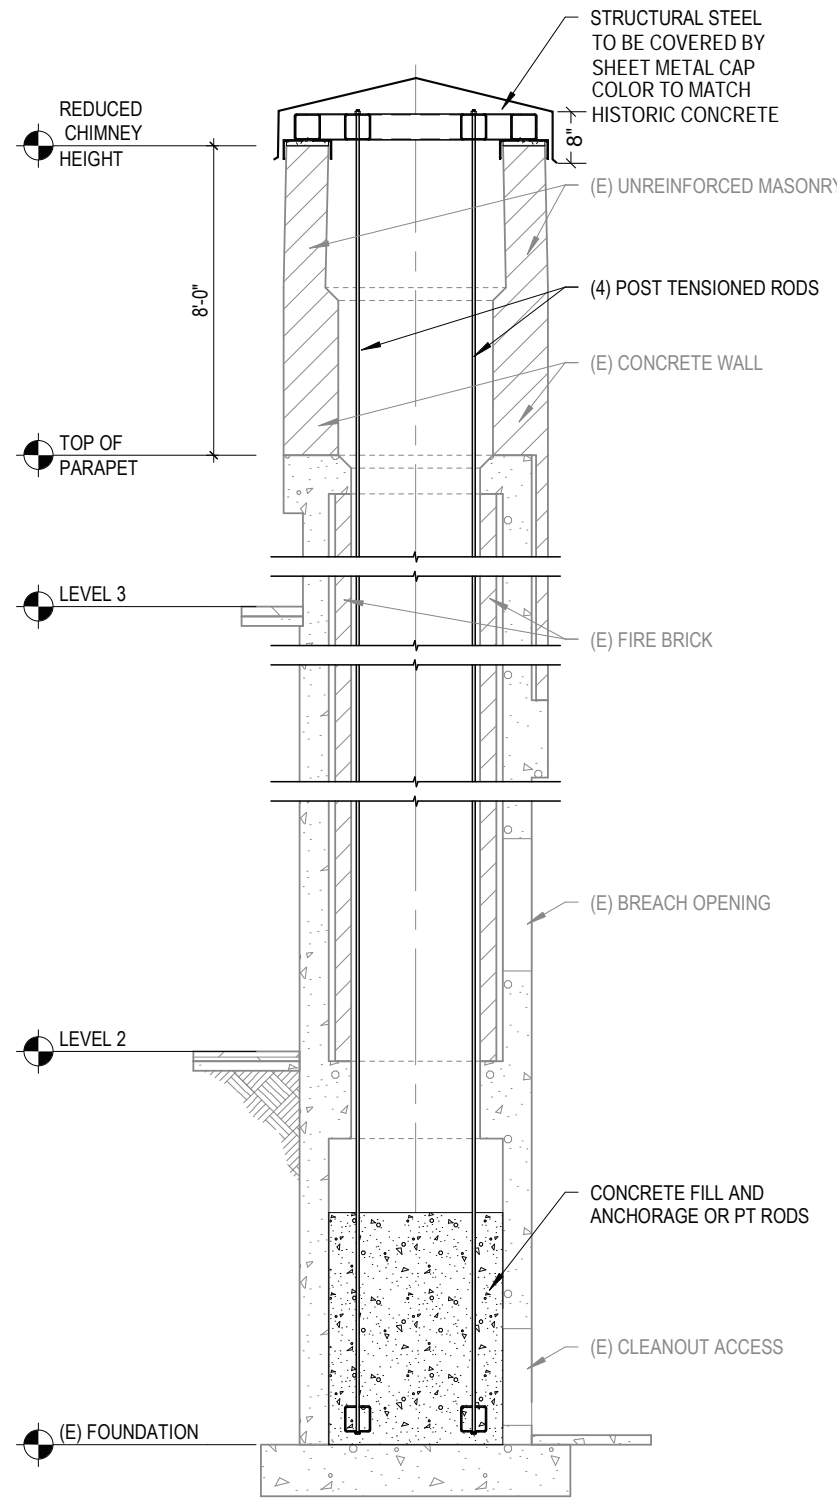
Structural Section through Historic Chimney

The existing historic chimney is required to be structurally stabilized in conjunction with the seismic improvements being made to the historic Montlake school building. While the primary school building is a concrete structure with brick applied to the face, the chimney component above the parapet is unreinforced masonry (i.e. solid brick with no internal steel reinforcement). As such, this portion of the chimney is extremely vulnerable to collapse in an earthquake. In general stabilization of chimneys is challenging and costly. The slender and tall shape does not offer much seismic resistance meaning that it takes a relatively large amount of strengthening to make these elements safe. The narrow interior openings also make installation more costly as there is no way to access the chimney from the inside to make connections to new structural elements. The design team has developed an effective strategy to stabilize the chimney, however, it requires the height of the chimney to be reduced. Structural analysis has confirmed that a chimney height of 8'-0" above the existing parapet allows the brick to function at the compressive loads that it was originally designed to take. The analysis also showed that heights above 8'-0" started to diminish the safety factor and increased the risk of shear failure in the brick. While the chimney is a notable historic feature for many schools of this era, the chimney is not currently visible from the front of the school. The chimney is primarily visible from the east side of the existing building. The proposed rendering shows that the chimney will still have a presence from this perspective and will continue to contribute to the overall building character. The design team believes that the proposed reduction in height provides a solution that increases student safety in a cost effective way that allows more funds to support educational programs, while still protecting an important historic feature.

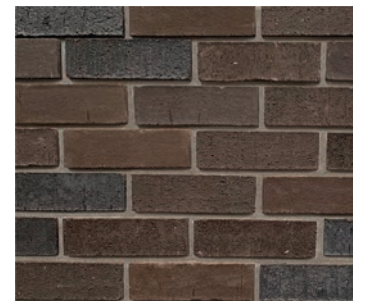
1C. Brick
Custom Brick Blend

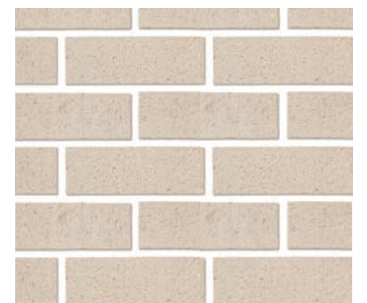
1E. Brick
Limestone in Smooth Texture

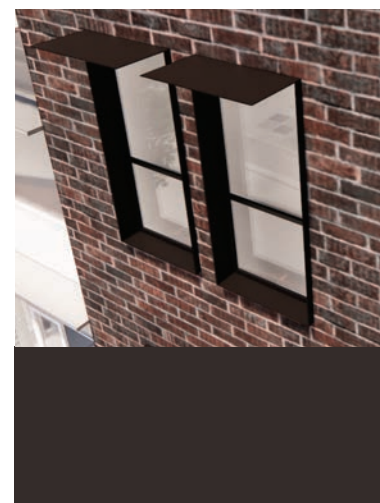
5A. Metal Flashings & Sunshades
CW-180 Bucktrout Brown

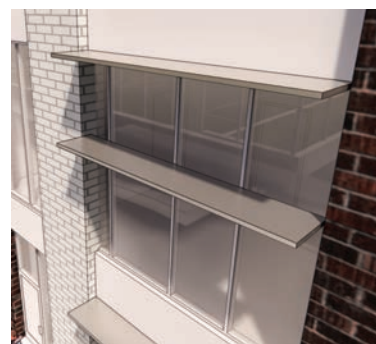
5B. Metal Flashings & Sunshades
SW Dove Wing OC-18

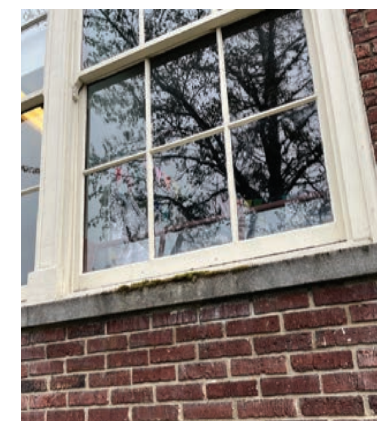
8A. Historic Windows
Color Match Existing

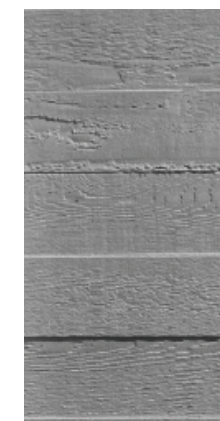
3A. Concrete
Board Formed
