MONTLAKE ELEMENTARY SCHOOL

SEATTLE PUBLIC SCHOOLS

**CERTIFICATE OF APPROVAL PACKET FOR SEATTLE LANDMARKS
PRESERVATION BOARD
SUBMITTED MARCH 10, 2023**

Modernization of and addition to the existing landmarked Montlake Elementary School on the same site, removal of all out-buildings and a reconfiguration of the school grounds.

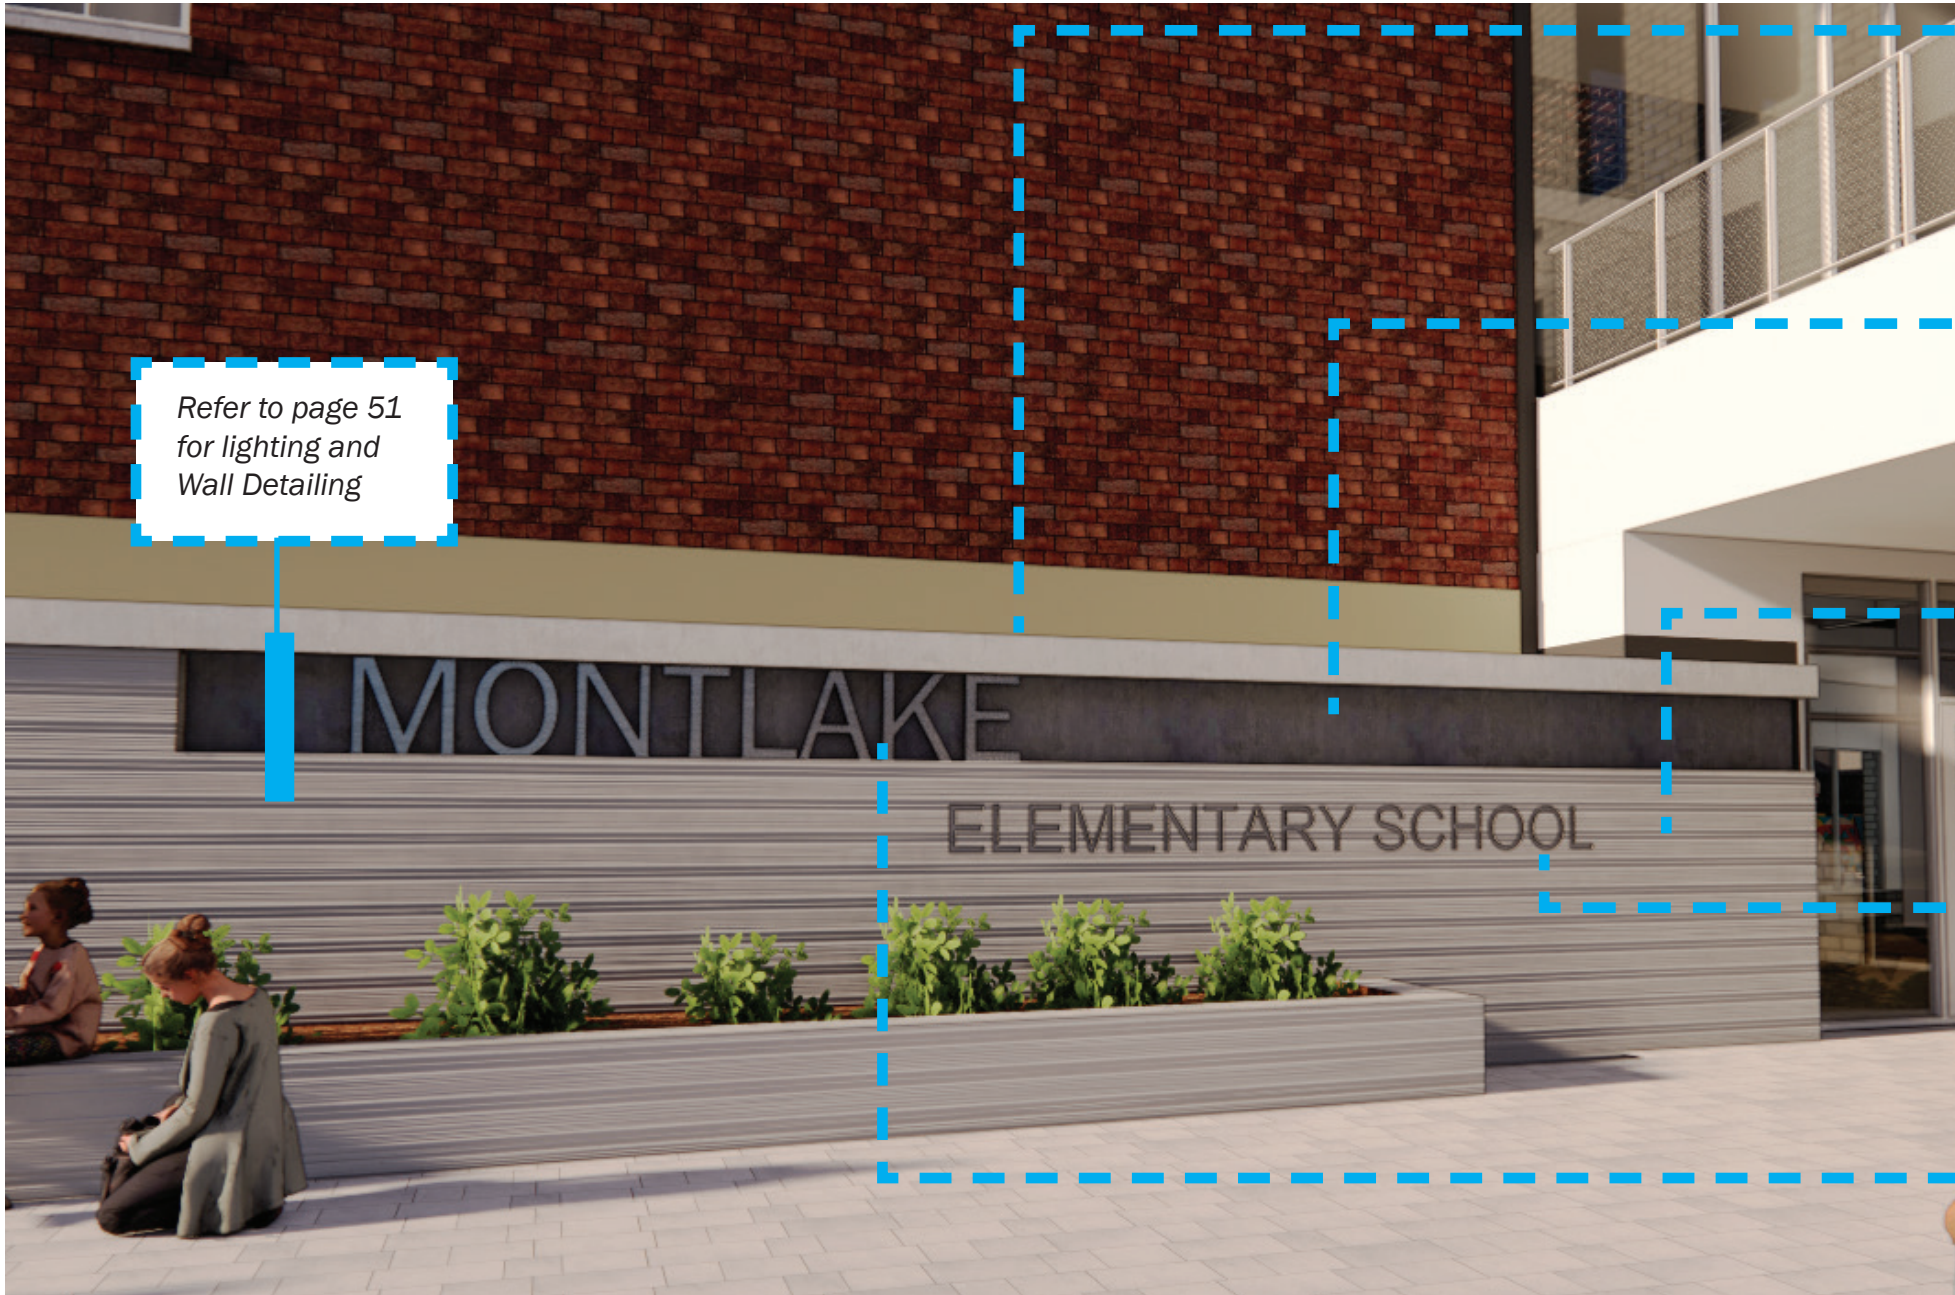
EXTERIOR BUILDING SIGN

Pre-cast Concrete Lid
1:20 Slope for Drainage

Acid Stained Concrete Indent
Color: Charcoal

Stamped Concrete Lettering
Color: Acid Stained Concrete in dark grey
Type Face: Ariel
Height: 10"
Depth: 1" depression in wall

Perspective of NE Entry Plaza Exterior School Sign

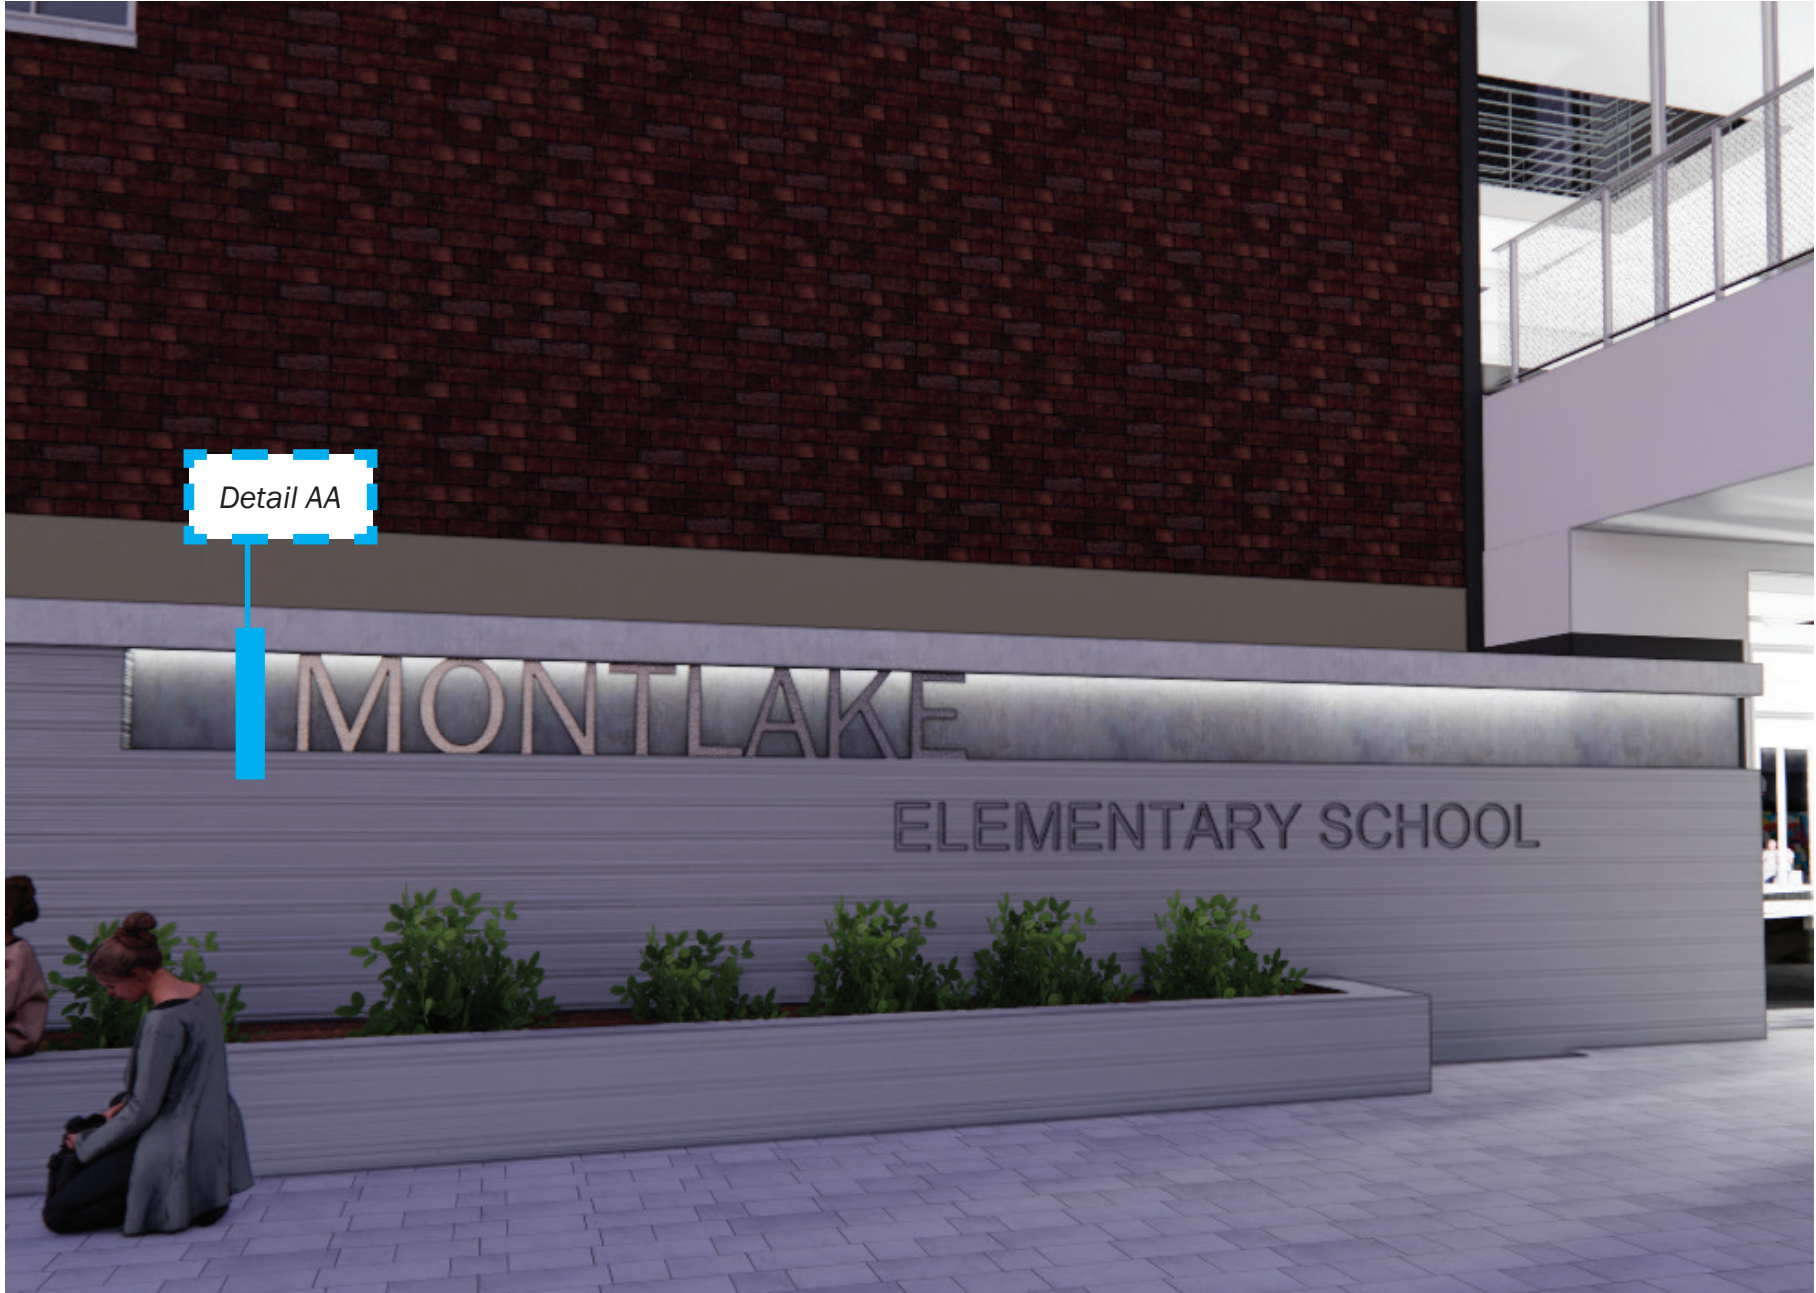
EXTERIOR BUILDING SIGN

Perspective of NE Entry Plaza Exterior School Sign Lighting

The proposed exterior building sign has been refined per feedback from the ARC to reduce the height of the letters and integrate more with the architecture. The metal letters are set in front of a carved out channel in the concrete retaining wall adjacent to the entry. This allows for subtle back lighting that provides a glow without any direct view of the light source. This ensures that glare is not an issue for neighboring properties.

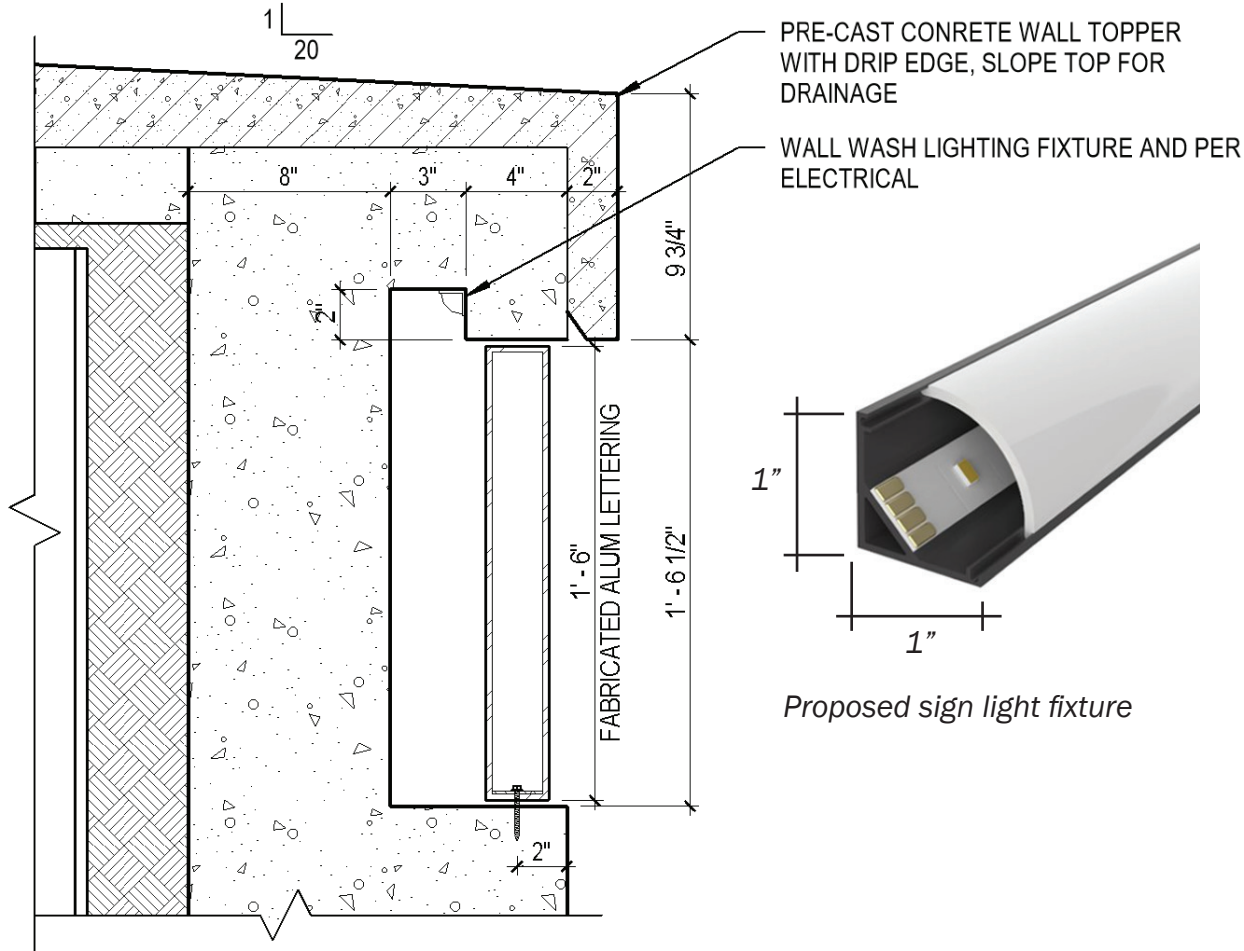
Detail AA: Section through Exterior Sign and Shoring Wall

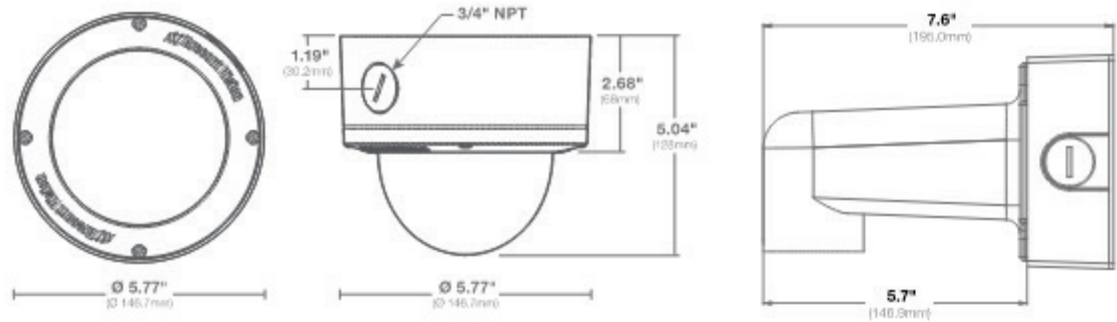
Proposed Security Camera and Mounting Arm (Arecont Vision - MegaDome G3)

Security Camera locations have been selected to balance functional needs for security coverage with aesthetic concerns related to the historic building architecture. The camera and mounting model selected has been used successfully at multiple historic schools within the district. See exterior elevations for proposed camera locations.

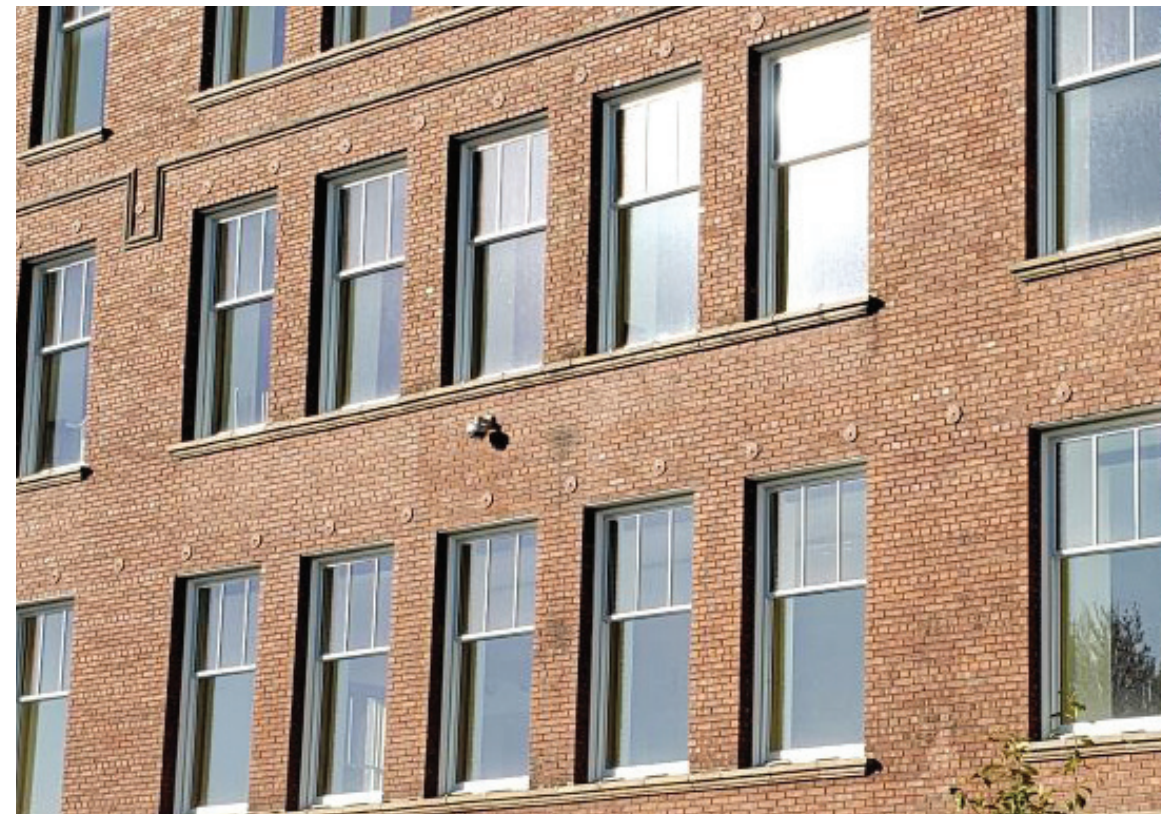
Installation of proposed security camera at Lincoln HS in Seattle

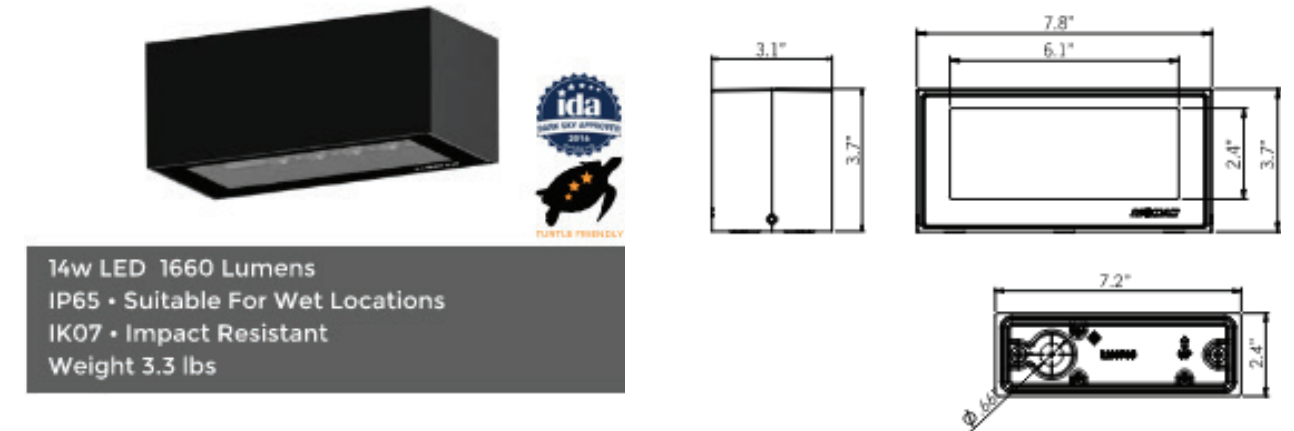
Exterior light fixtures have been selected to provide the necessary exterior lighting for safety and security while also being unobtrusive and not detracting from the historic architecture. A similar fixture type has been used at other historic schools within the district. See exterior elevations for proposed light fixture locations.

Proposed Exterior Light Fixture (Ligman ULEE-30011)

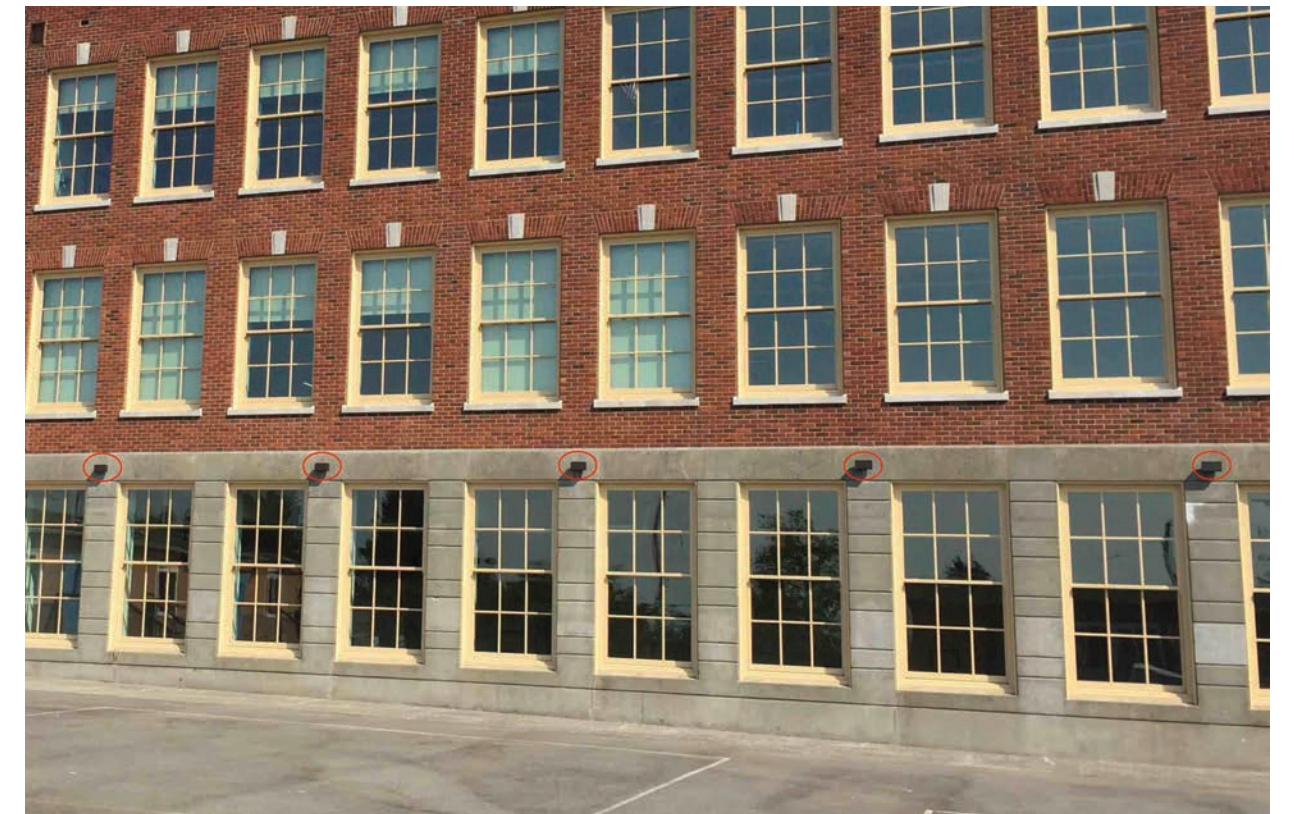
Similar light fixture installation at E.C. Hughes Elementary in Seattle

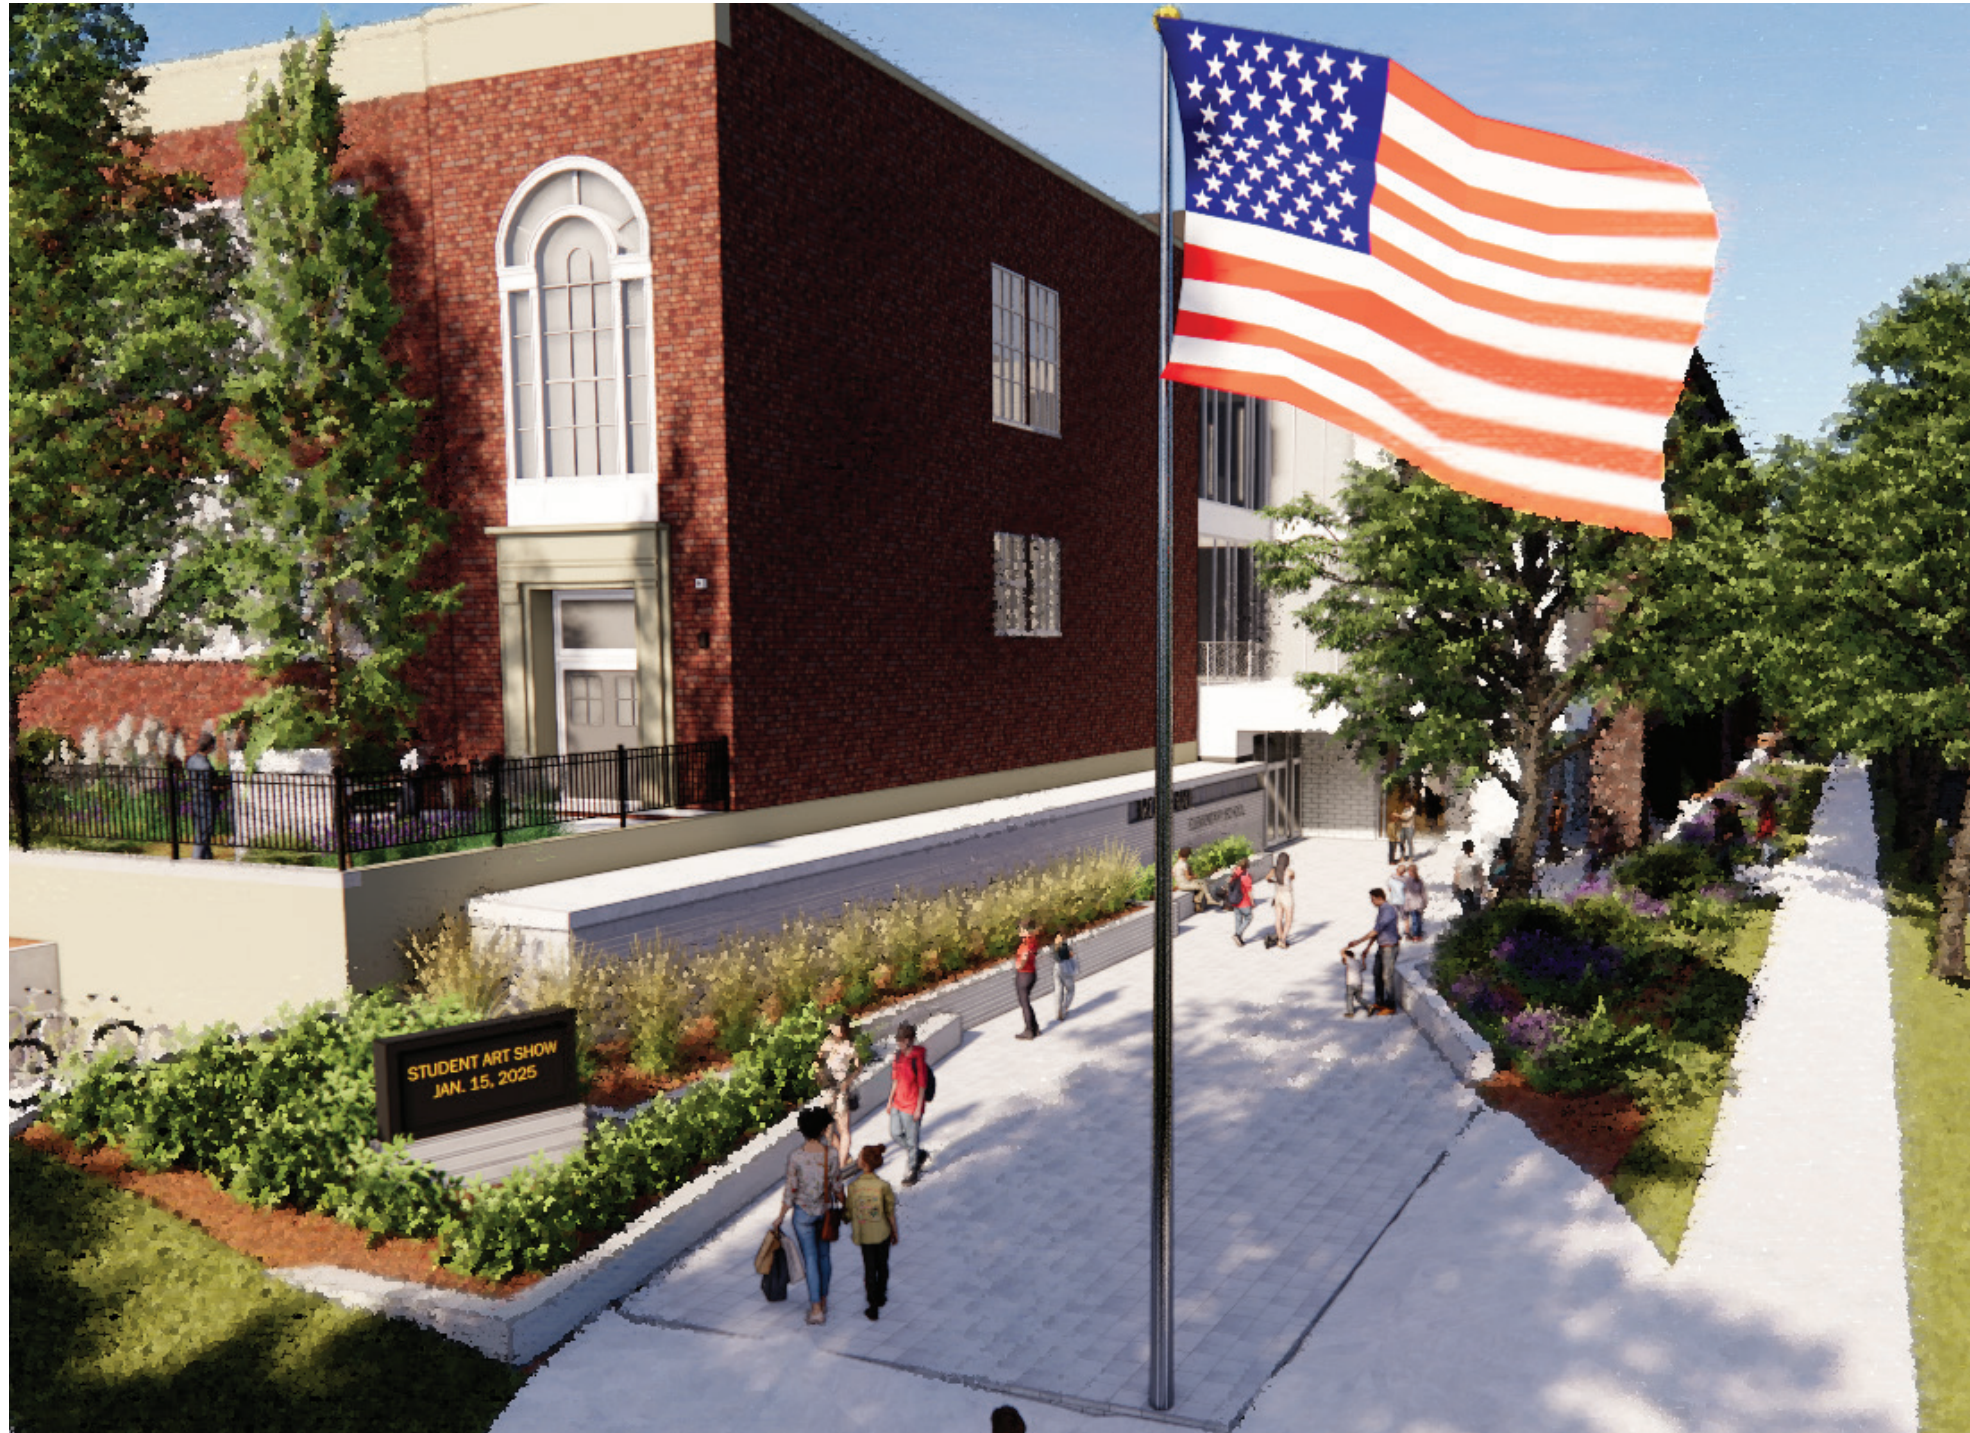
Proposed Electronic Reader Board Location (View from the 22nd and E Calhoun St.)

Seattle Public Schools is currently seeking a departure to include an electronic reader board sign outside of the school. The intent of this sign is to inform the school and larger community of events and notices. The sign will be programmable and the displayed information would change, but will not include video, flashing, scrolling, or moving images. The operating hours for the sign will be limited to 7am - 9pm. The digital format will keep the community informed of events at the school and will allow messages to be displayed in multiple languages to increase equity in school communications.
